Preliminary Ignition Investigation Report

Ignition Database Index:	20240753
Electric Incident Investigation (EII) Number:	N/A
Incident Name:	Morro - 25 Jun 2024
PG&E Facility Ignition?	Yes
CPUC Reportable Ignition?	Yes
Date & Time of Incident:	June 25, 2024 @ 2013 hours
Street Address:	In the vicinity of 10450 Morro Road, Lewis Highway 41 and Toloso Road.
City:	Atascadero
County:	San Luis Obispo
Latitude/Longitude:	35.456902, -120.687541
State Responsibility Area (SRA) / Local Responsibility Area (LRA) / Federal Responsibility Area (FRA)	Local Responsibility Area (LRA)
PG&E Division:	Los Padres
High Fire Threat District (HFTD):	Tier 2
High Fire Risk Area (HFRA):	Yes
EPSS Buffer:	No
Fire Index Area (FIA):	575
Fire Potential Index (FPI) Rating: FIA	R3
Fire Potential Index (FPI) Rating: Circuit	R4
Was there a PSPS event at the time of ignition?	No
Suspected Initiating Event:	Utility work / Operation
Failure Driver:	Utility work / Operation
Failure Sub-driver:	Equipment failure - Other

Circuit:	Atascadero 1103
Circuit Protection Zone:	Atascadero 1103440856
Nominal Voltage:	12kV
Pole SAP Equipment ID:	SAP Pole ID: 101932126
Subject to PRC 4292 Veg Pole Clearance:	No
PG&E Equipment ass

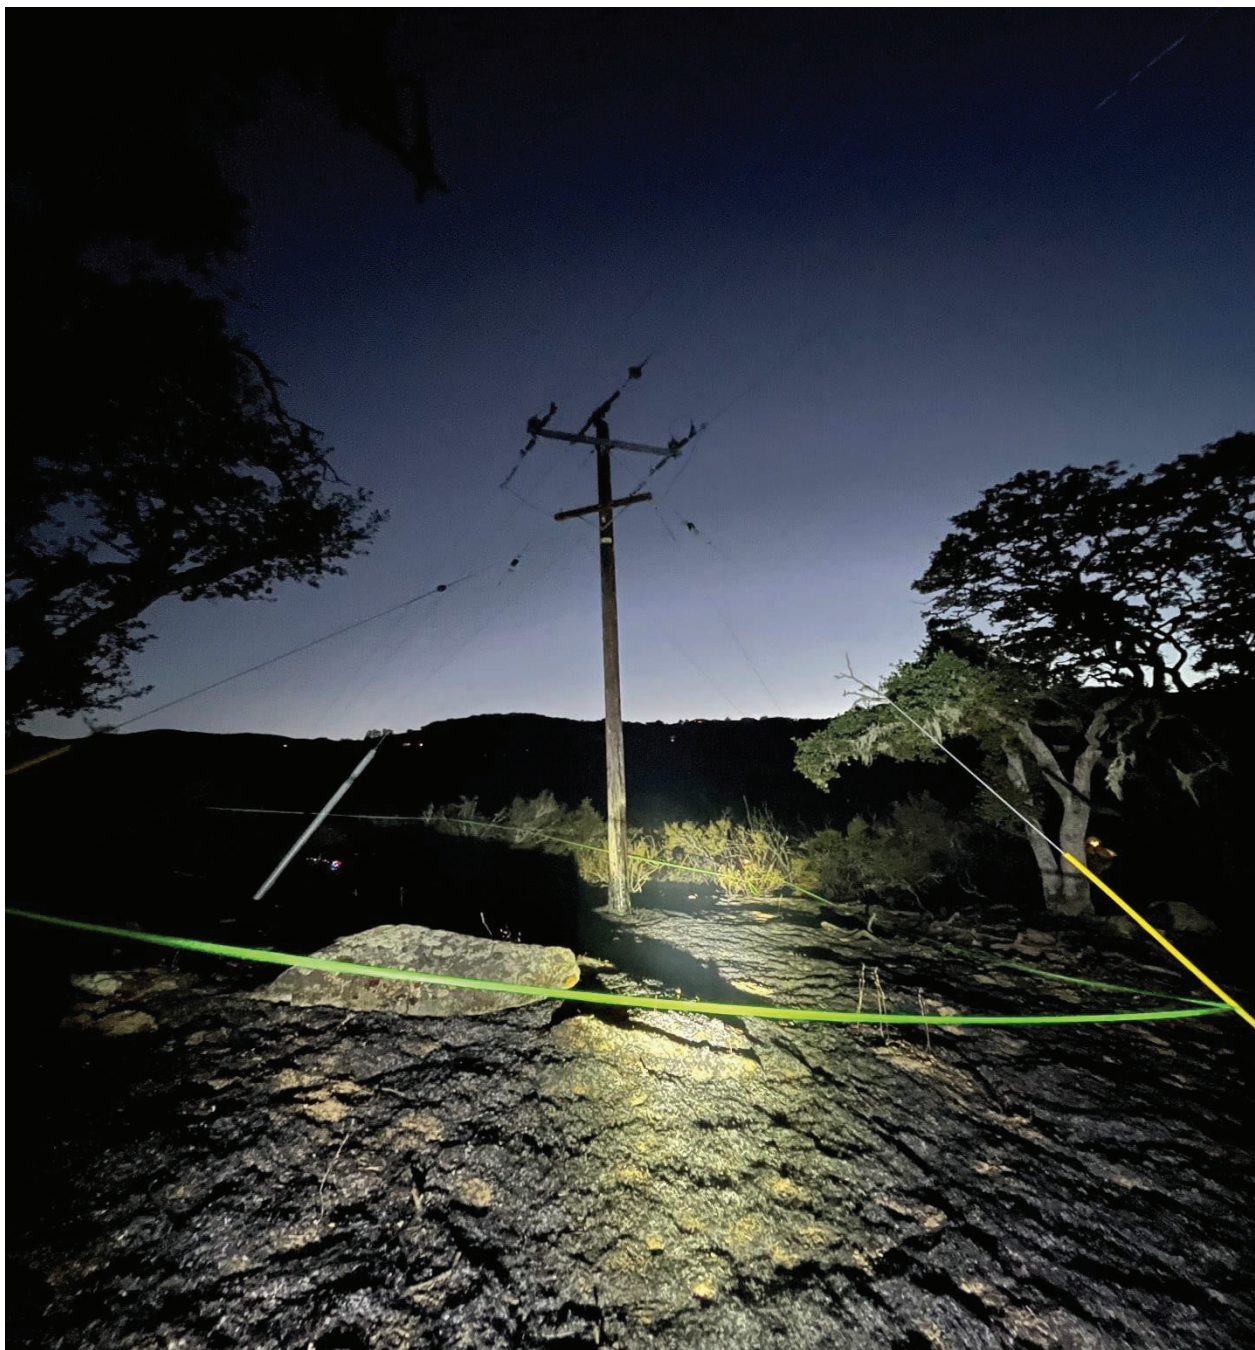
The fire is listed as the "Morro - 25 Jun 2024" fire in the Hazard Awareness Wildfire Command (HAWC) fire activity report. The ensuing fire had spread to about 100-foot by 100-foot spot (based on the HAWC summary) in size and was suppressed by the Atascadero Fire Department on June 25, 2024, (see Figure 6).

Figure 3 - 100-foot by 100-foot fire burn scar area at (SAP Pole ID: 101932126). Picture taken by the troubleshooter on June 25, 2024

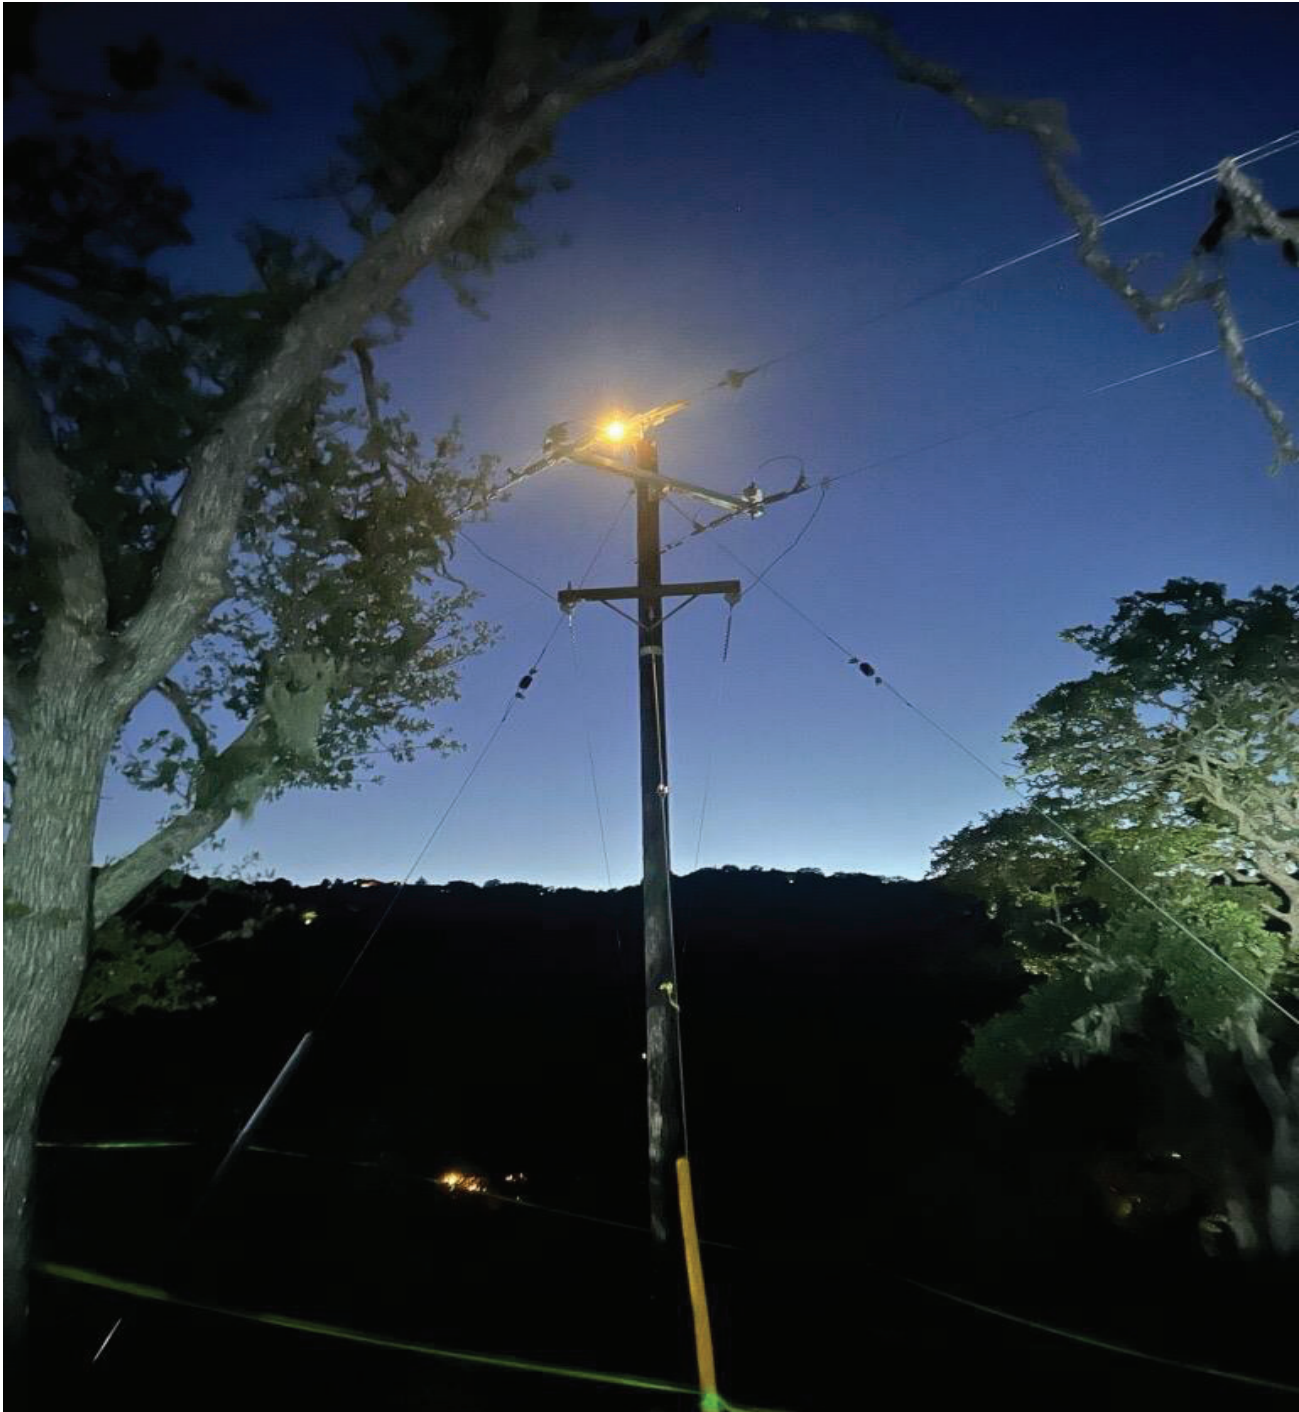
The PG&E troubleshooter arrived on the scene at approximately 2041 hours and observed a fire on the side of the mountain. The troubleshooter indicated that the fire department showed him videos of our equipment sparking and requested that the Distribution Operator (DO) de-energize. Arcing was visible at the jumper on the dead-end bolted clamp shoe attached to the insulator at the top of the line-and-buck pole (SAP Pole ID: 101932126), (see Figures 3, 4, 5, and 6).

Figure 4 – Arcing and burnt jumper at the dead-end strain bolted clamp shoe attached to the insulator at the top of the line-and-buck pole (SAP Pole ID: 101932126). Picture taken by the troubleshooter on June 25, 2024.

The PG&E repair crew arrived onsite at 2302 hours to replace all cross-arms and associated hardware on SAP Pole ID: 101932126. All repair work was completed by the PG&E Crew at 0445 hours on June 26, 2024.

LC priority "A" Tag (#129127893) was created to replace all cross-arms and associated hardware on SAP Pole ID: 101932126. All repair work was completed by the PG&E Crew at 0445 hours on June 26, 2024.

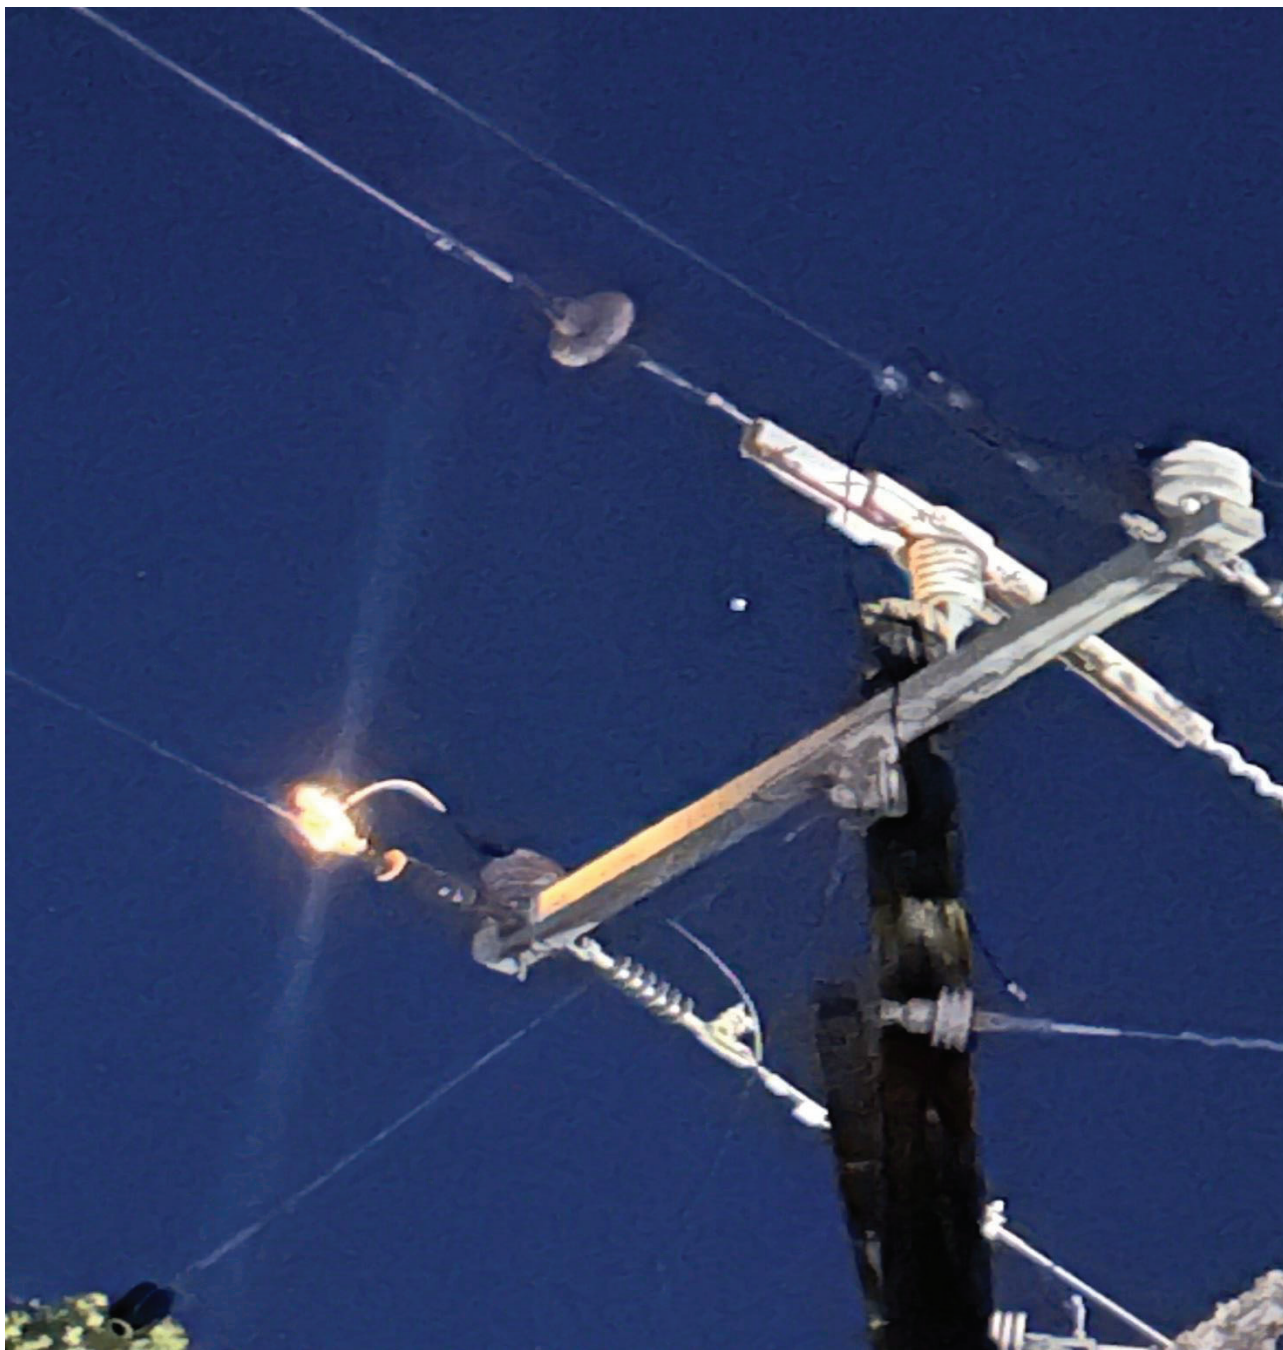
Figure 5 – Close-up view of the arcing and burnt jumper at the dead-end strain bolted clamp shoe attached to the insulator. Picture taken by the troubleshooter on June 25, 2024

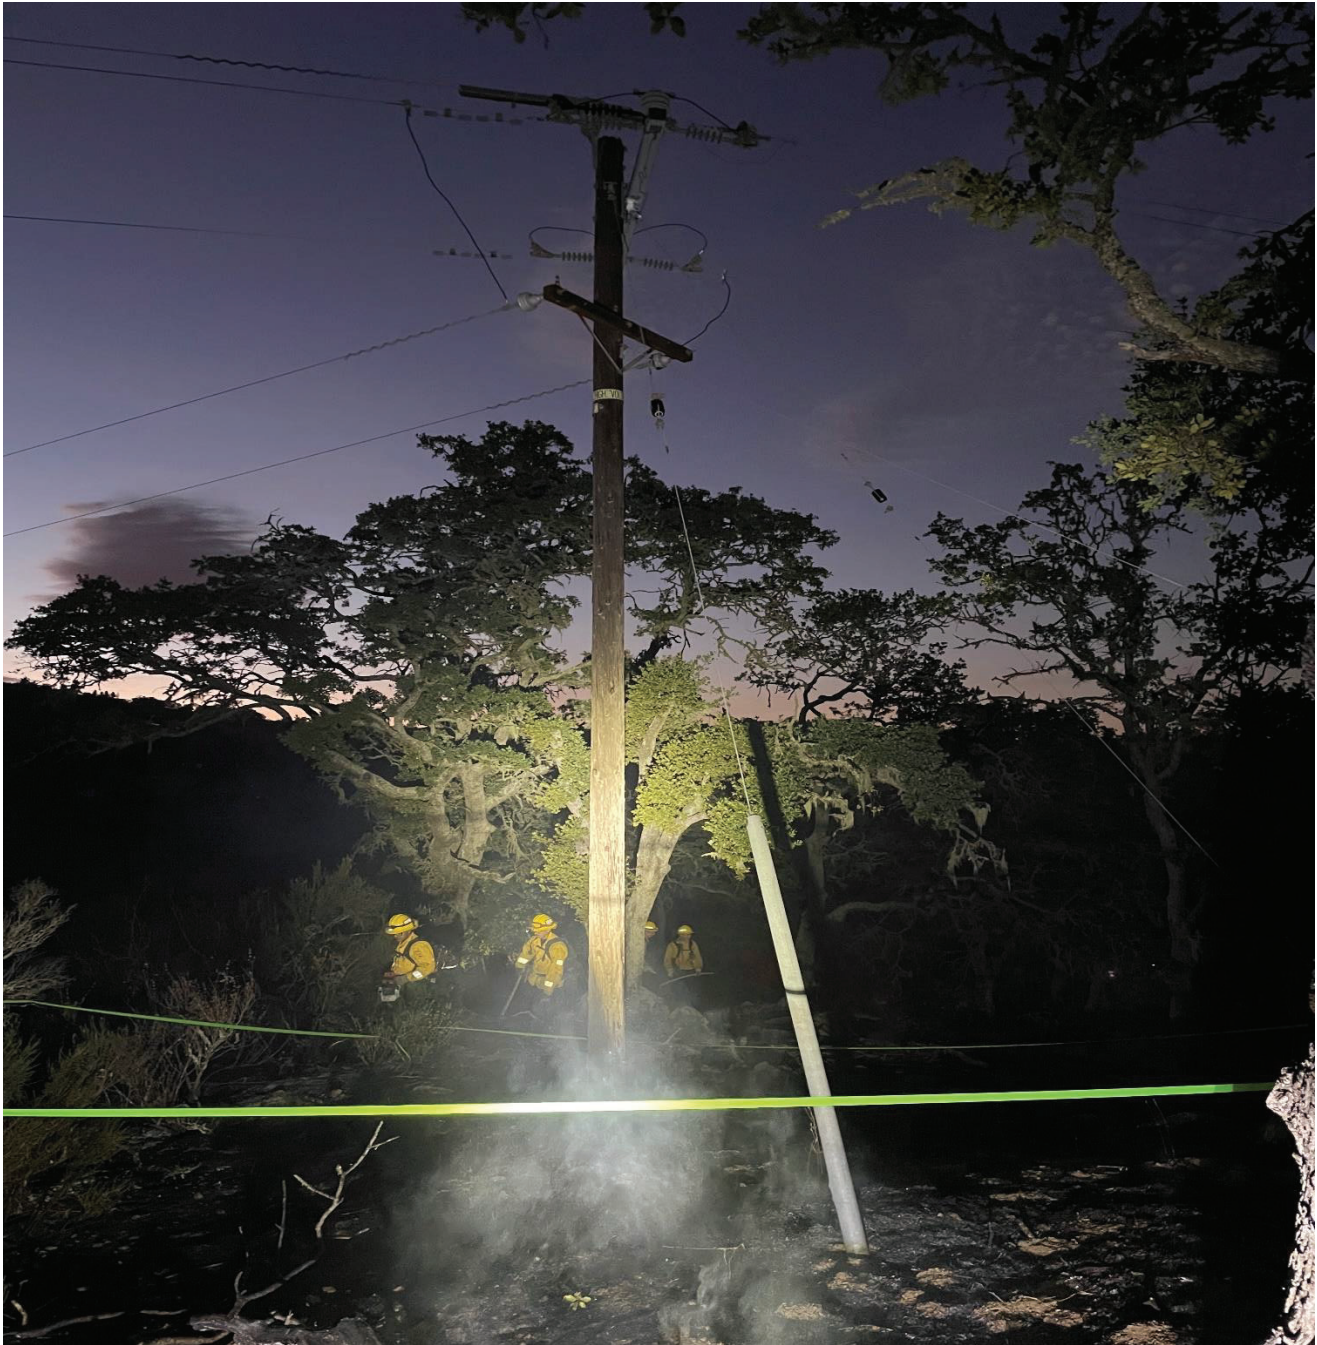
Figure 6 – The Atascadero Fire Department was on site to control and suppress the less than 10-acre fire, picture taken by the troubleshooter on June 25, 2024.

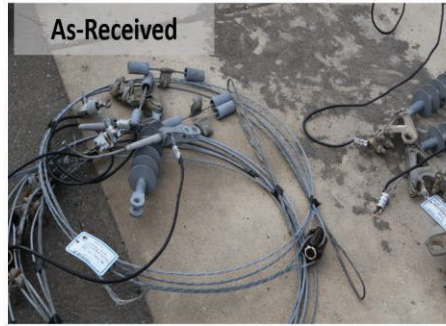
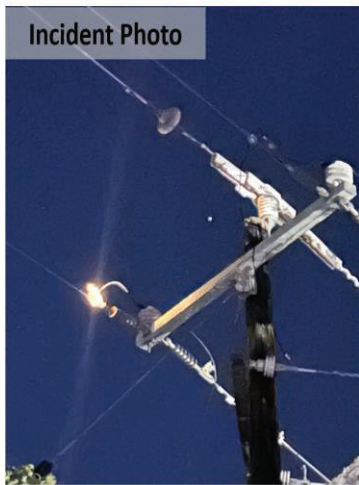
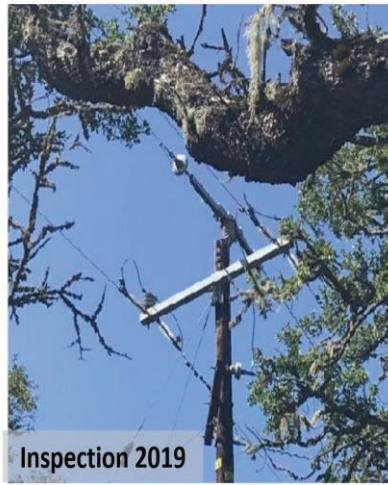
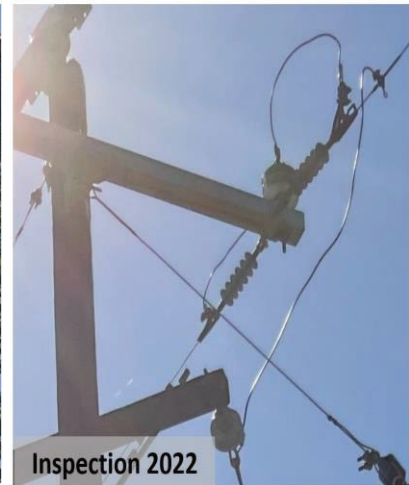
While the direct cause of the failure cannot be determined, per ATS analysis, the ignition was caused by the dripping of molten material from a failed H-connector, connecting the Copper jumper to an Aluminum Conductor Steel-Reinforced (ACSR) conductor. Inspection of the collected material shows significant thermal damage and loss of material on the connector, mostly concentrated around the aluminum conductor.

The cross-arm was rebuilt in 2019 by a contractor with new insulators, connectors, and jumpers. The connector subsequently failed five years later. The suspected cause is most likely poor workmanship. This type and size of connector need four crimps instead of the three that were done. H-type connectors are a very reliable connector when installed properly, but there has been an uptick in failures over the past few years that have been attributed to workmanship issues. Most of these new failures have failed within five years of installation.

Figure 7 - The vegetation fire was ignited by molten material dripping from a failed H-connector that linked the copper jumper to the Aluminum Conductor Steel-Reinforced (ACSR) conductor.

Asset Failure Analysis (AFA) has recommended tailboarding crews with a 5MM to ensure that the entire restoration, construction, and contract teams are aware of the uptick in ignition incidents and some of the misses that led to the ignition regarding H-type connector installation (proper number of crimps), cable preparation, and proper taping. Also, a reminder that the preferred method is fired wedges and of the distribution standards 041010, [here](#).

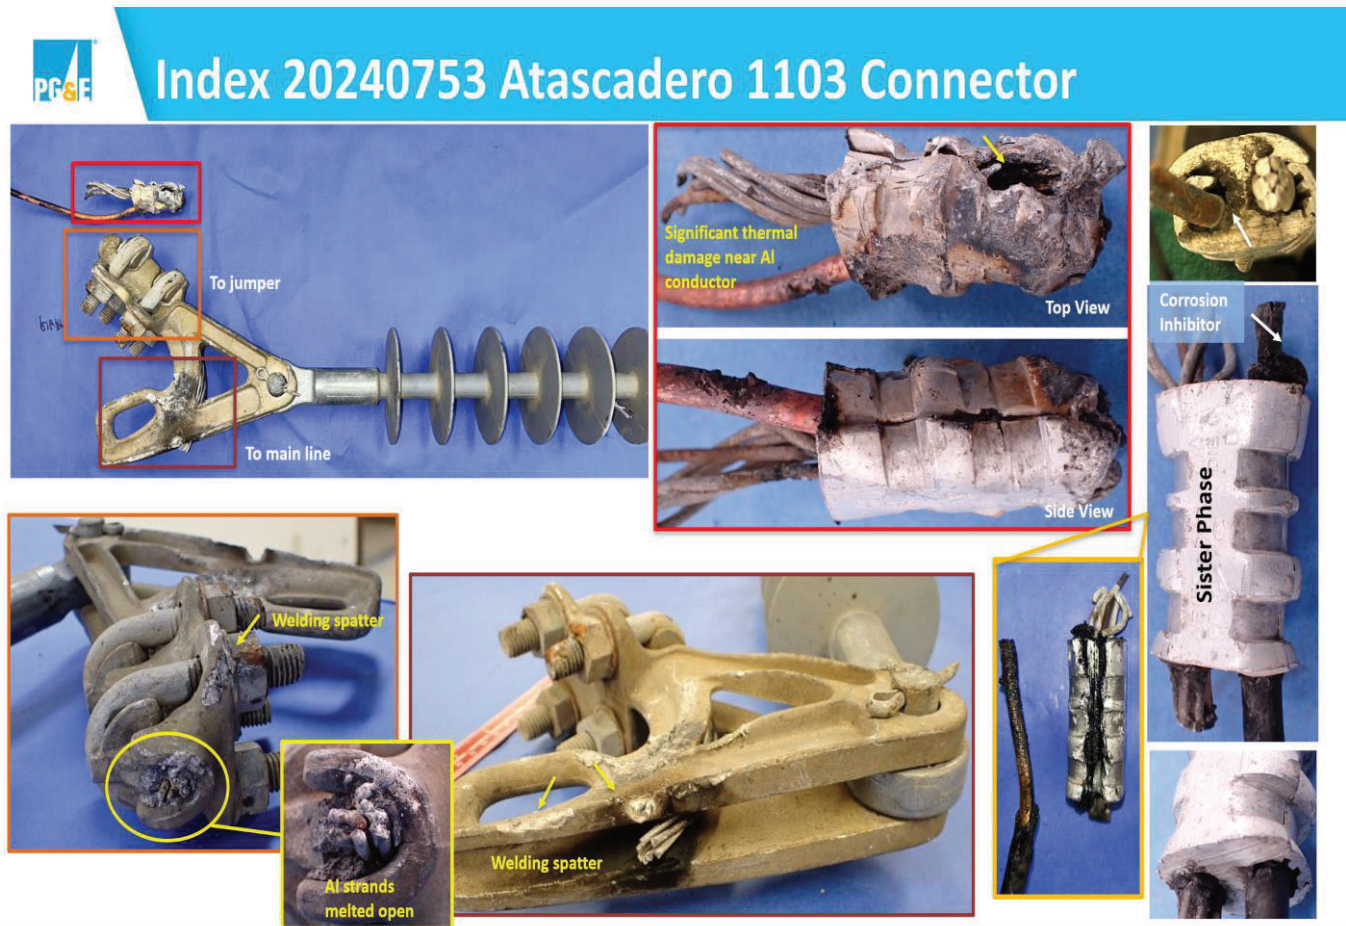
The fire was ignited by molten material dripping from a failed H-connector that linked the copper jumper to the Aluminum Conductor Steel-Reinforced (ACSR) conductor. An inspection of the collected materials revealed extensive thermal damage and material loss on the connector, particularly around the aluminum conductor. Although workmanship in the form of inadequate crimping may have contributed to the failure, it is not known if it was a direct cause of the failure. The sister connectors did not exhibit problems like corrosion, loose connection, or the ingress of foreign materials hindering the electrical flow, (see Figures 7 and 8). The exact cause of the failure remains unknown at this time.

Figure 8 - An inspection of the collected materials revealed extensive thermal damage and material loss on the connector, particularly around the aluminum conductor.

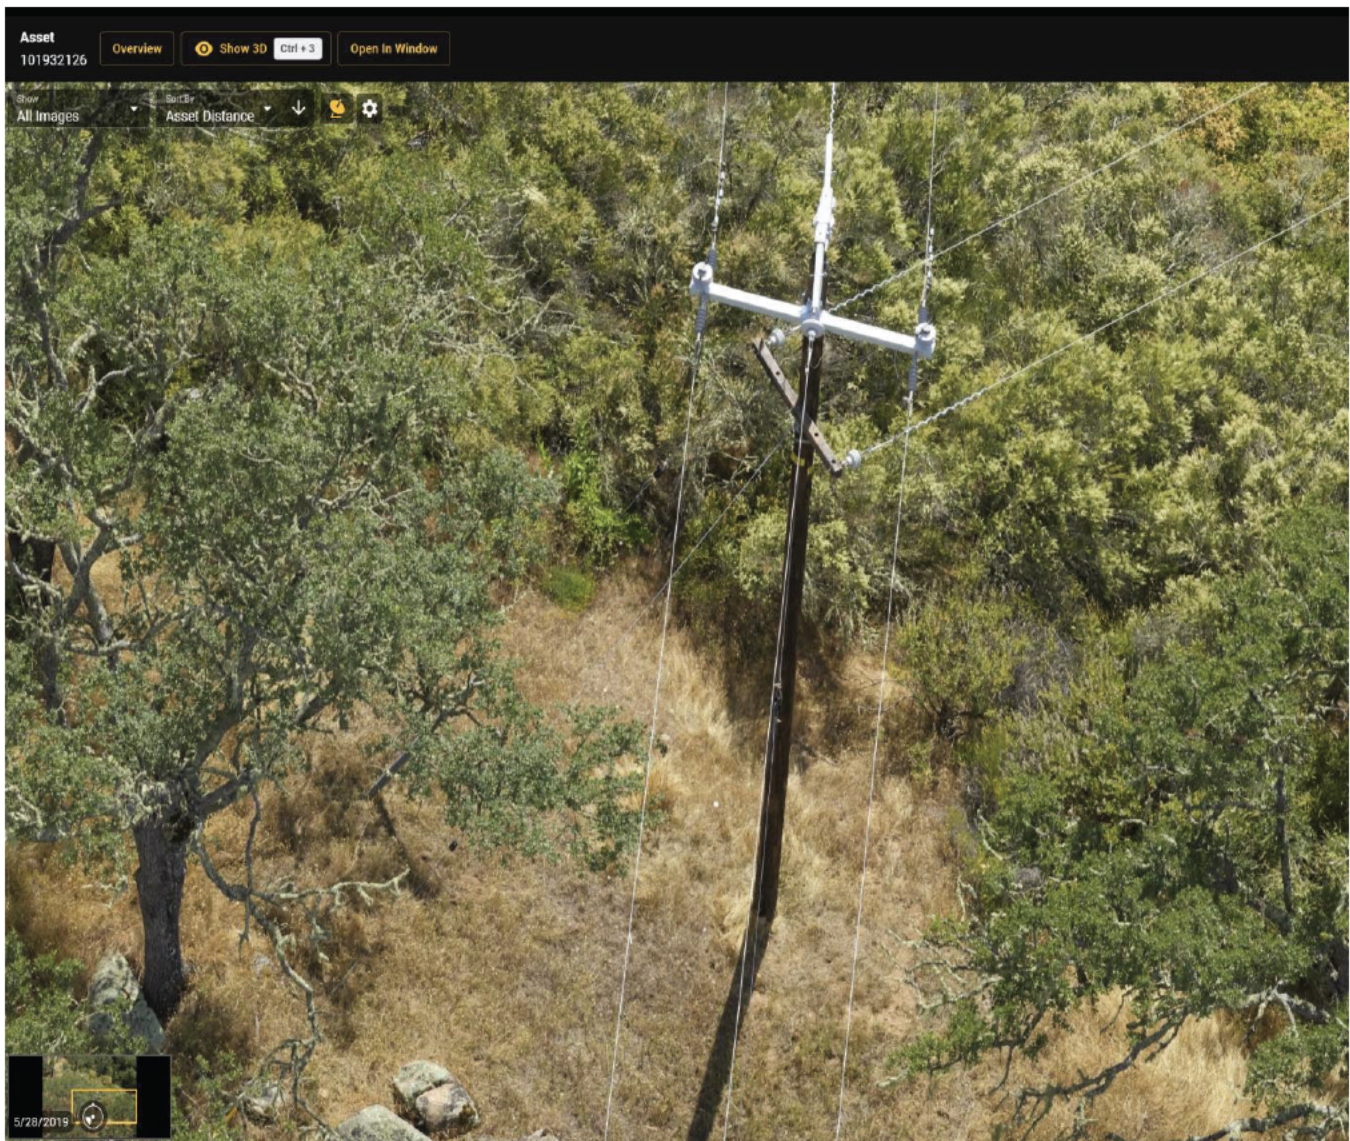
Figure 9 - SAP Pole ID: 101932126 (Incident Pole), picture taken from Shaper Shape dated May 28, 2019
