Job Aid: Overhead Assessment

Publication: Jan 4, 2024, Effective: Feb. 1, 2024

Introduction to Job Aid: Overhead Assessment

This job aid is designed to assist Electric Distribution Compliance Inspectors, PG&E Employees, and Contractors in assessing and prioritizing compelling **abnormal conditions** on overhead facilities, including but not limited to GO 165 Inspections. Compelling Abnormal Condition is defined as any electric distribution pole, equipment, component, conductors, vegetation, or third-party condition that causes a safety or fire ignition risk that, in the judgment of the field employee, may adversely impact public safety and/or service reliability.

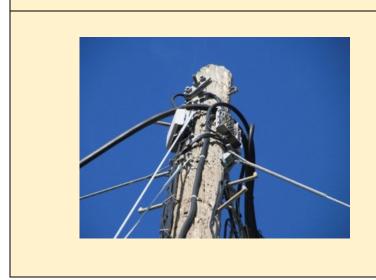
COMMUNICATION IN CLIMBING SPACE

Obstructed climbing space, access via bucket truck from street below. Also, look for clearance issues between communications facilities and the PG&E down guys.

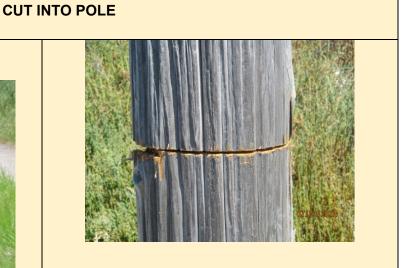
At this Location: Vandalized pole. Chain saw cut into lower portion of pole. Arc length 20 inches (>40% circumference)

FDA= Pole / Broken / Damaged / Replace

Priority= A Tag, Follow the emergency process due to damage claim.

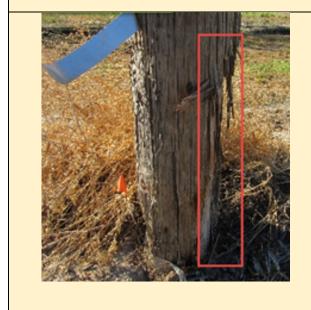
SIGNIFICANT REDUCED CIRCUMFERENCE (TRACTOR DAMAGE)

At this Location: Significant Reduced Circumference (Tractor Damage). Refer to reduction in cross-sectional area flow chart.

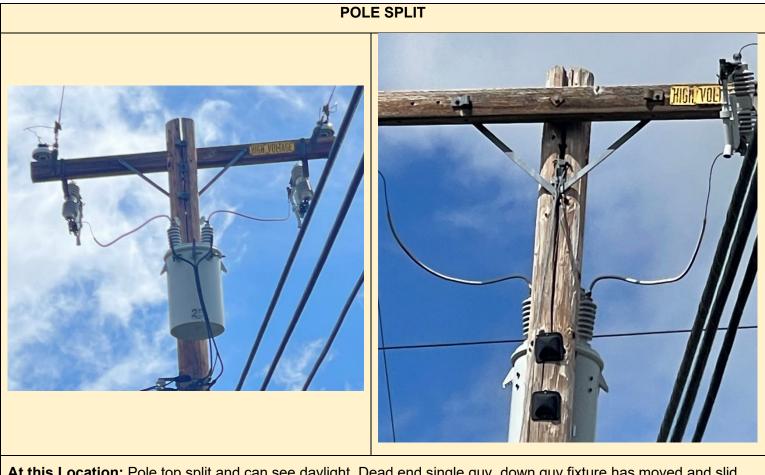
At this Location: Pole top split and can see daylight. Dead end single guy, down guy fixture has moved and slid down from original location onto the brace. Cross-arm brace hardware also compromised. No split bolt.

FDA= Pole / Broken / Damaged / Replace

Priority= X Tag, depending on exposure.

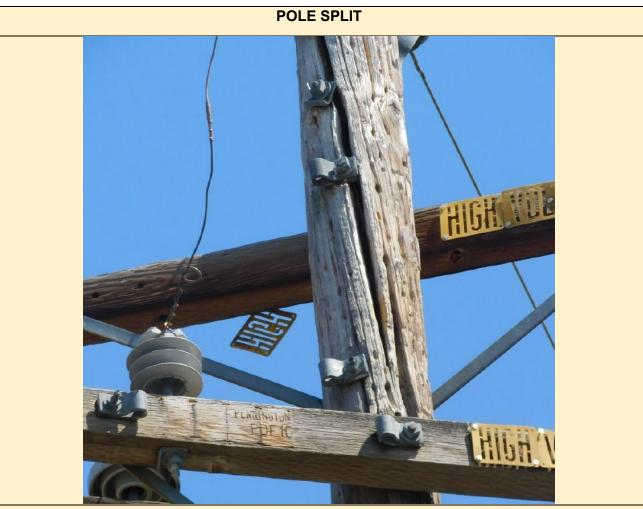
At this Location: Checks are opening on the pole at the equipment level. Multiple checks, possible movement on the cross-arm hardware, at the brace bolt on the top cross-arm. Hardware sinking in, pole twist spiral.

FDA = Pole / Broken / Damaged / Replace

Priority = Minimum E Tag, depending on exposure

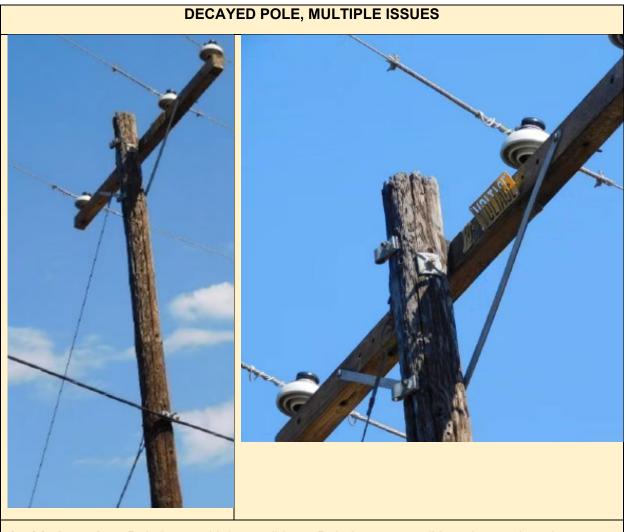
At this Location: Pole has multiple conditions: Pole in poor condition, decayed, and extensive weathering, and pole top rot. Pole checks alone are not a compelling abnormal condition, but in combination with all the other conditions, write EC tag.

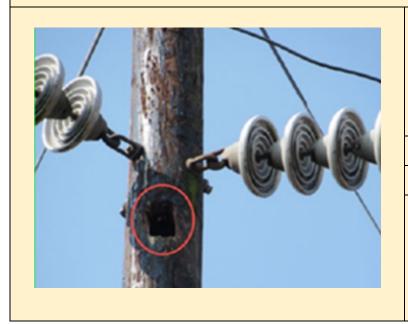
WOODPECKER DAMAGE >3 INCHES

At this Location: Woodpecker hole is greater than 3 inches, less than 12 feet from top of pole, and within 2 inches from attachment hardware.

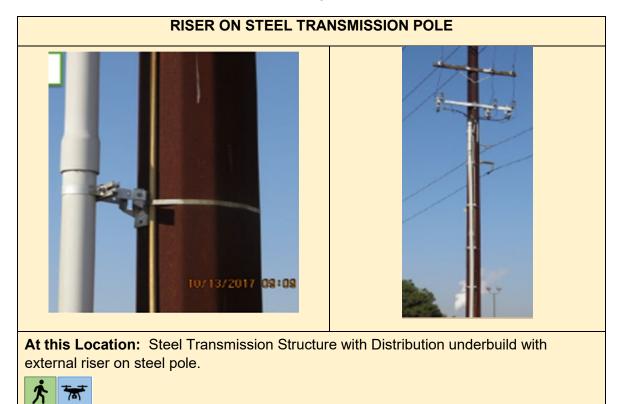
General Guidance: Steel Transmission Structure with Distribution Underbuilds with **<u>external</u>** riser present. If observed, yes, create EC notification to relocate riser.

Note: Presents of distribution riser on steel transmission pole exposes customer equipment to transmission flashover voltages.

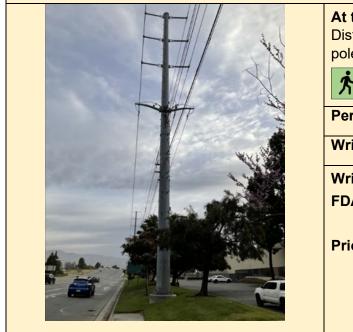
STEEL TRANSMISSION STRUCTURE WITH DISTRIBUTION UNDERBUILD WITH INTERNAL RISER WITHIN STEEL POLE

At this Location: Steel Transmission Structure with Distribution underbuilds with internal riser within steel pole.

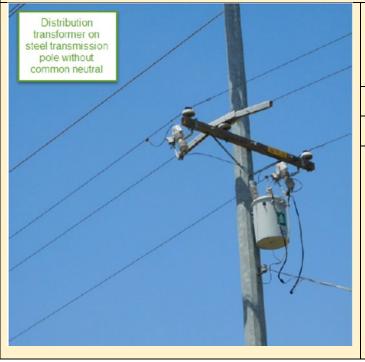
DISTRIBUTION TRANSFORMER ON STEEL TRANSMISSION POLE WITHOUT COMMON NEUTRAL

At this Location: Distribution transformer on steel transmission pole without common neutral.

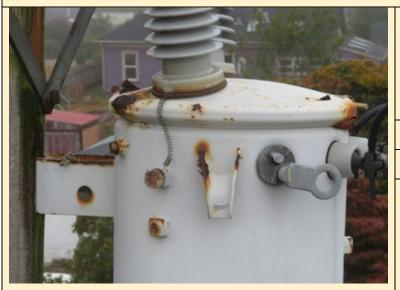
OH CORROSION

At this Location: Corrosion Weakening Integrity of Tank. Metal is separating into layers. Corrosion will breach tank.

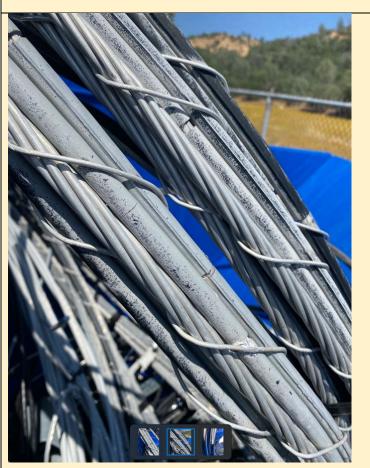
CRACKED SERVICE

At this Location: Corrosion, lashing is fused to conductor, hot leg is clearly exposed.

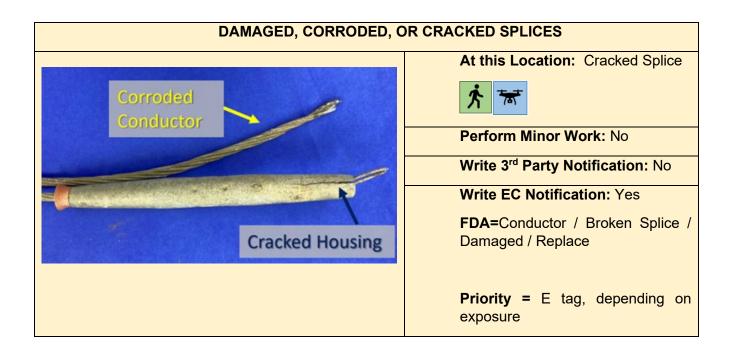
Example

Visually check for excessively corroded or damaged connectors and dead-end hardware which has a potential to fail, drop conductor, or cause an ignition.

- General Guidance: If observed, create EC Notification to replace connectors or deadend hardware
- F. Is the splice/connector damaged, corroded or cracked?
 - 1. (No) No Action
 - 2. (Yes) Repair/Replace E Tag

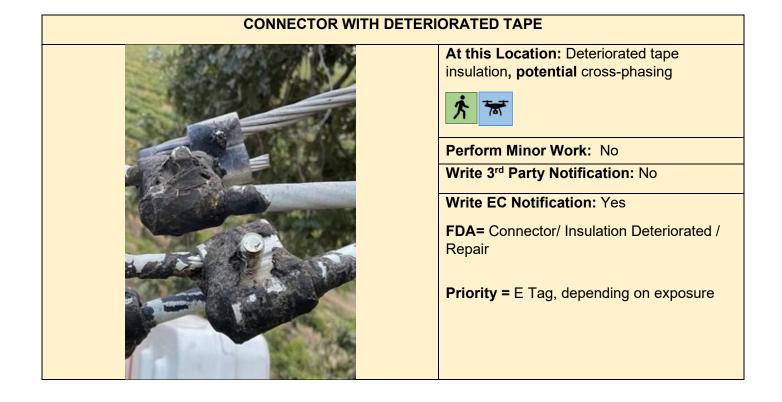
Example

G. Is the insulation tape on connector deteriorating?

- 1. (No) No Action
- 2. (Yes) Repair/Replace E Tag

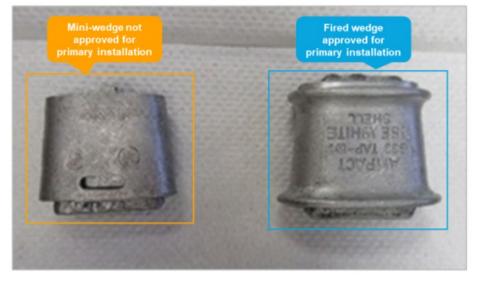
Wedge Connectors

Example slide 132: Approved and Unapproved connectors for primary.

Guidance: If yes, write EC notification to replace connector.

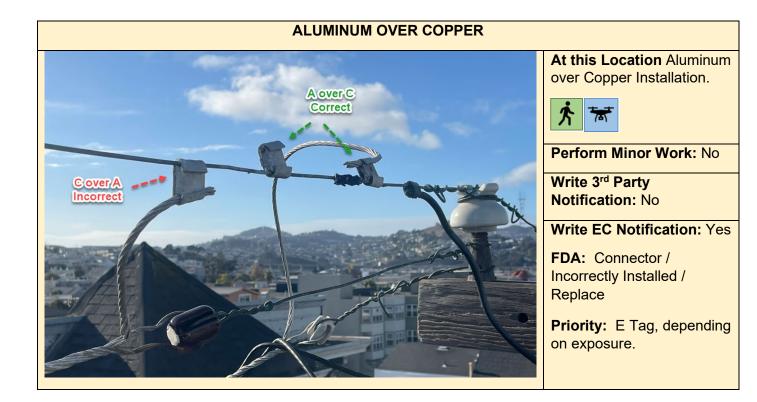
Proper installation is <u>Aluminum over Copper</u>.

M. Is dissimilar metal connection(s) made with the CU over AL?

Guidance: If installed incorrectly, write EC notification to replace connector.

- 1. (No) No Action
- 2. (Yes) Repair/Replace E Tag

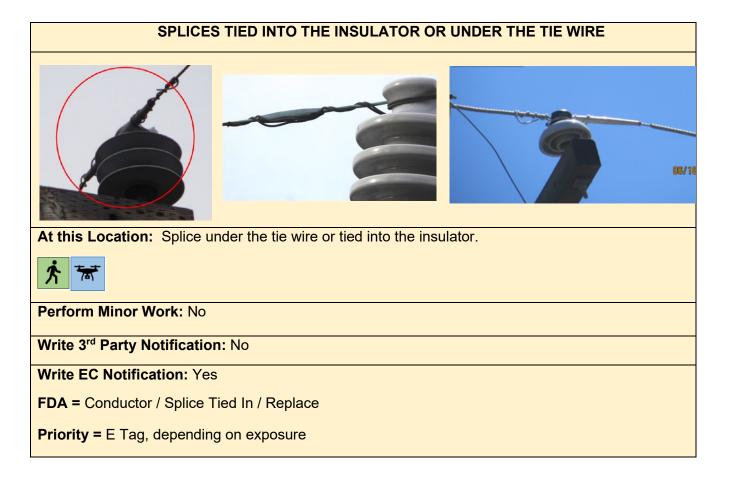
Examples

SPLICES TIED INTO THE INSULATOR OR UNDER THE TIE WIRE – AERIAL VIEW At this Location: Splice under the tie wire or tied into the insulator. Splice bent / damaged.

FDA = Conductor / Splice Tied In / Replace

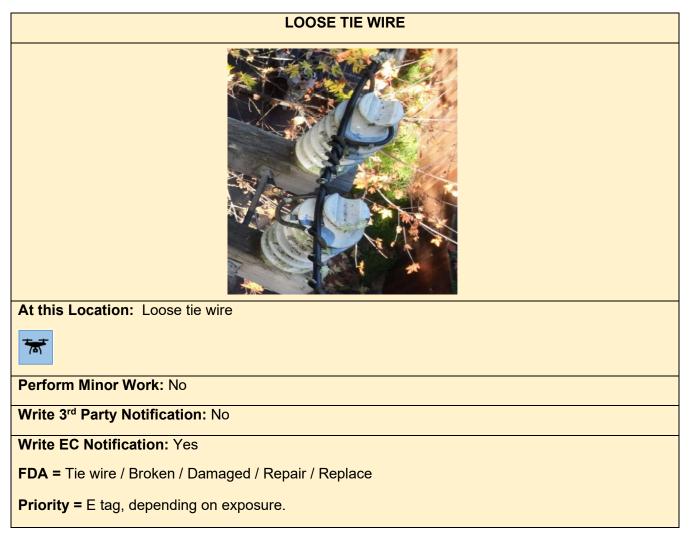
Examples

P. Is the tie wire loose or hand tie slipping?

- 1. (No) No action
- 2. (Yes) Imminent expectation of failure? Or tie wire off insulator?
 - a. (No) Repair/Replace E Tag
 - b. (Yes) Repair/Replace Level IA or IIX

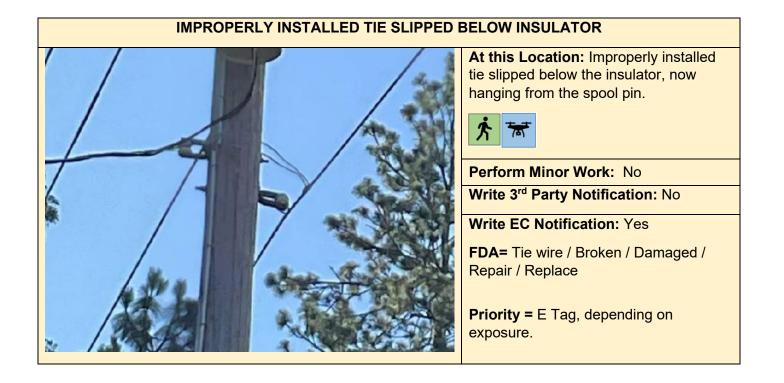
Examples

R. Is the tie wire improperly installed?

- 1. (No) No action
- 2. (Yes) Is it possible for the conductor to become unattached from the insulator?
 - (No) Repair/Replace E Tag
 - o (Yes) Repair/Replace Level IA or IIX

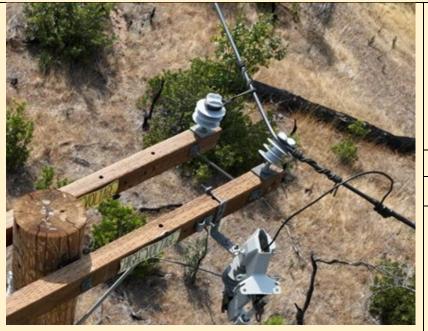
ANGLE POLE WITH TIE WIRE, BENT STEEL PIN

At this Location: Angle pole with post top insulator, where the inside angle insulator conductor is only being supported by tie wire (non-clamped). Post top insulator steel pin is bent.

FDA= Tie wire / Broken / Damaged / Repair / Replace

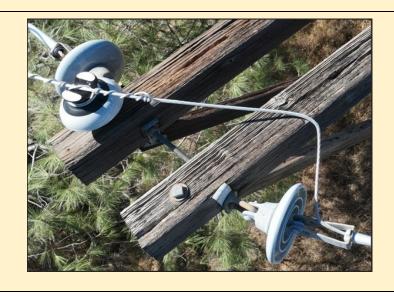
INSUFFICIENT CLEARANCE – AERIAL VIEW

At this Location: Over the top jumper laying on cross-arm.

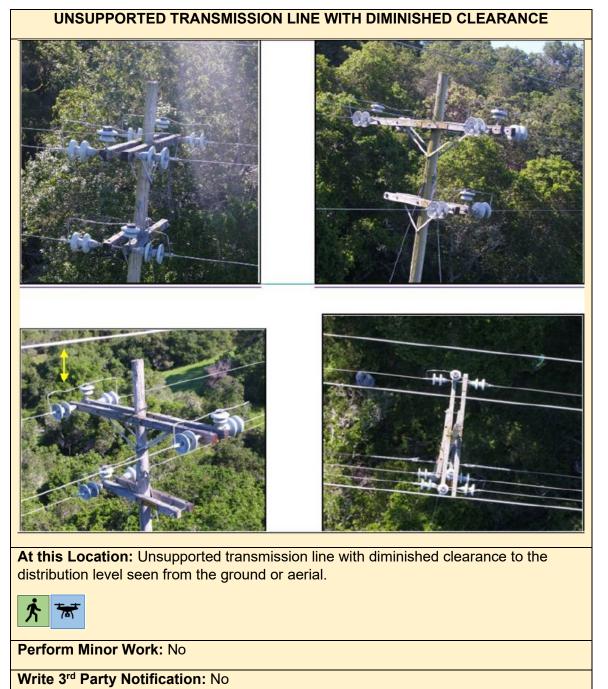
Example

W. Is the conductor sagging and does not meet the required clearance distance?

- 1. (No) No action
- 2. (Yes) Is there a public safety hazard?
 - a. (No) Repair/Replace E Tag
 - b. (Yes) Repair/Replace Level IA or IIX

Write EC Notification: Yes

FDA = OH Facility / Transmission Issue / Create LC

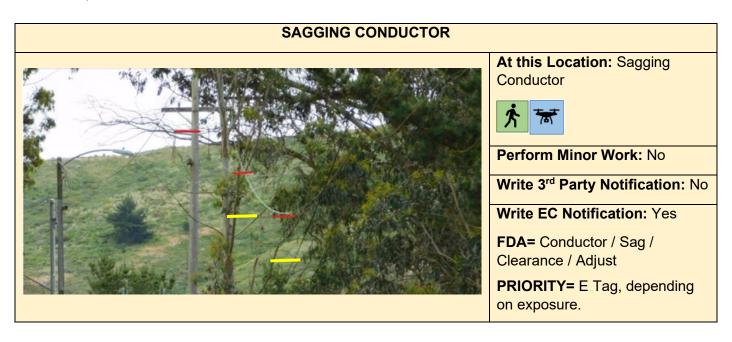
Examples

- 1. (No) No action
- 2. (Yes) Is the conductor low or in danger of making contact to adjacent phase or object?
 - a. (No) Repair/Replace E Tag
 - b. (Yes) Repair/Replace Level IA or IIX

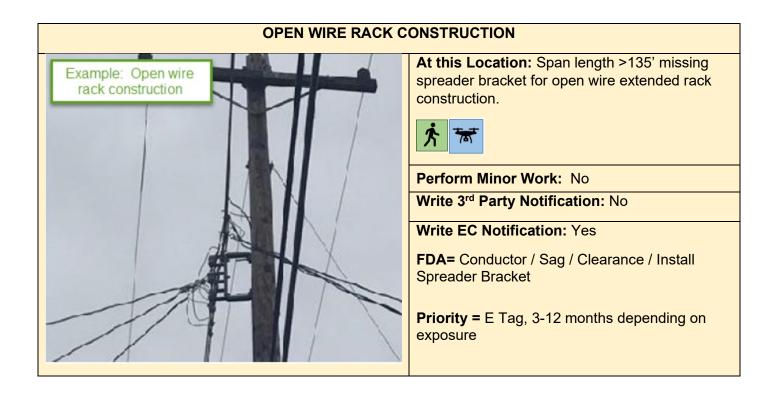
- Rev: 12
- A. Open wire secondary conductor with rack construction has missing spreader brackets for spans > 135'.

General Guidance: If observed, create EC Notification to have spreader brackets installed where bucket truck accessible; use line of sight and if available, foremancane or rangefinder.

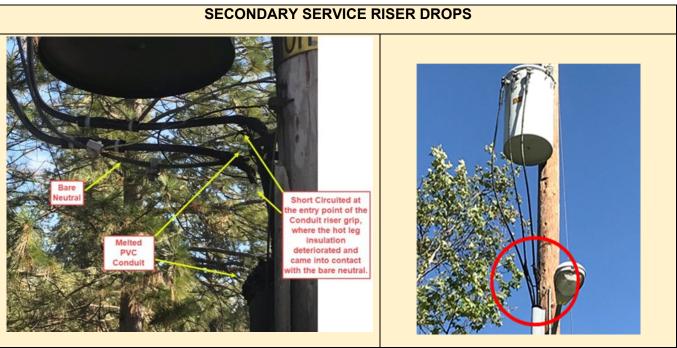
At this Location: hot leg insulation frayed at the point of entry point of the molding exposing the conductor into contact with the neutral

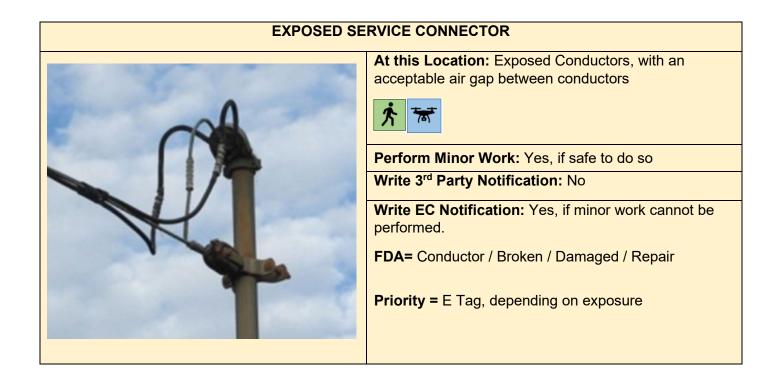
Examples

D. Is service conductor insulation cracked, abrasions, holes?

- 1. (No) No action
- 2. (Yes) Can Minor work be performed?
 - a. (No) Repair/Replace E Tag
 - b. (Yes) Perform Minor Work

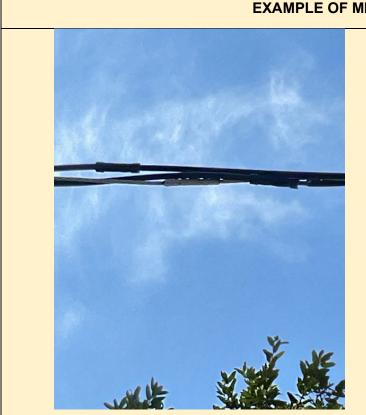
EXAMPLE OF MINOR WORK

At this Location: Hot leg is exposed next insulink

FDA= Conductor / Broken / Damaged / Repair

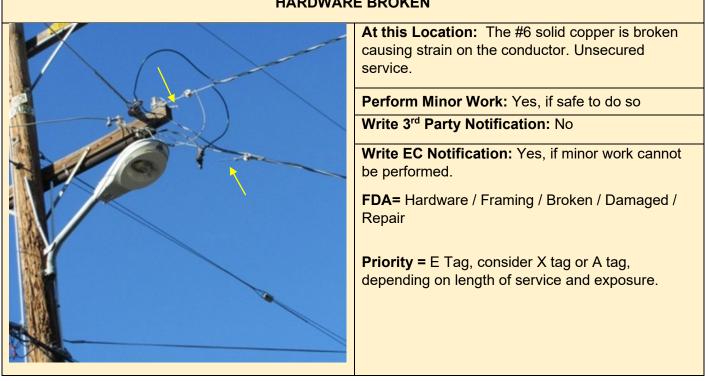
HARDWARE BROKEN

Category 2 – Broken Service Bob

- 1. (No) No action
- 2. (Yes) Can Minor work be performed?
 - a. (No) Repair/Replace E Tag
 - b. (Yes) Perform Minor Work

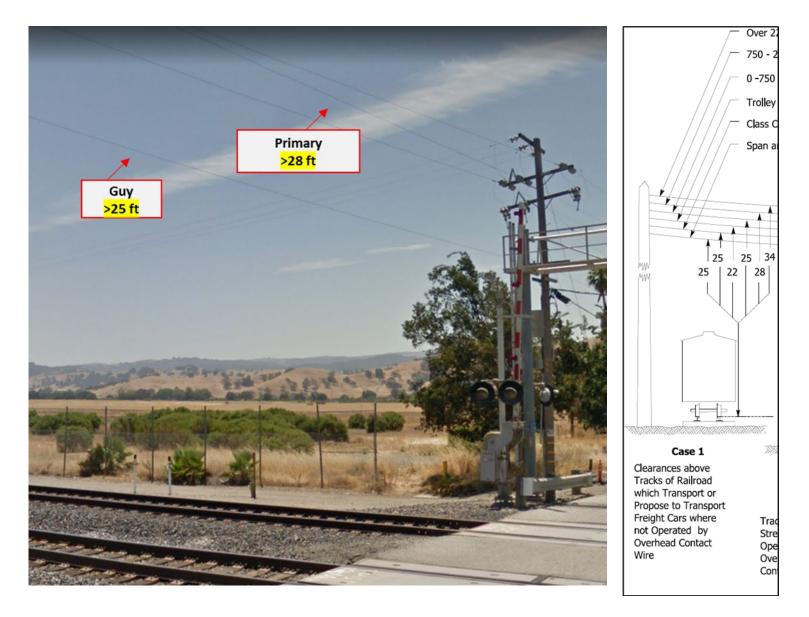
Case 1: Non-Contact Railroad

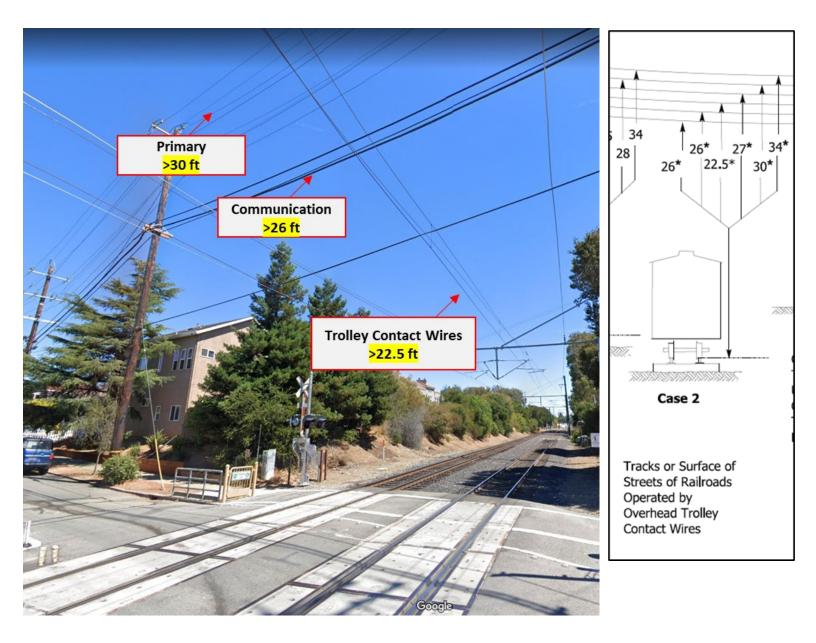
Case 2: Contact Railroad

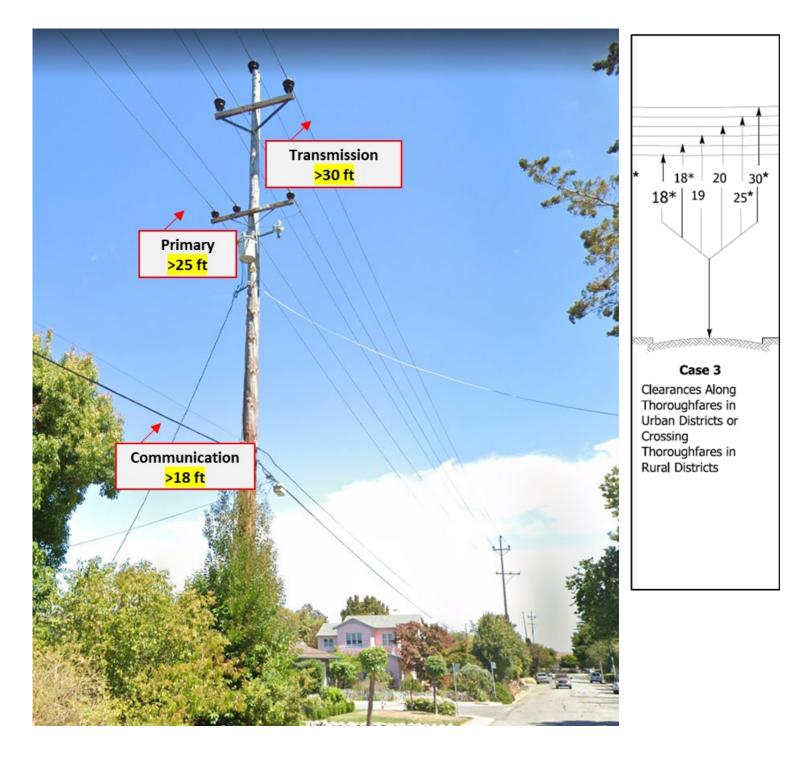
Case 3: Along or Crossing an Urban Road

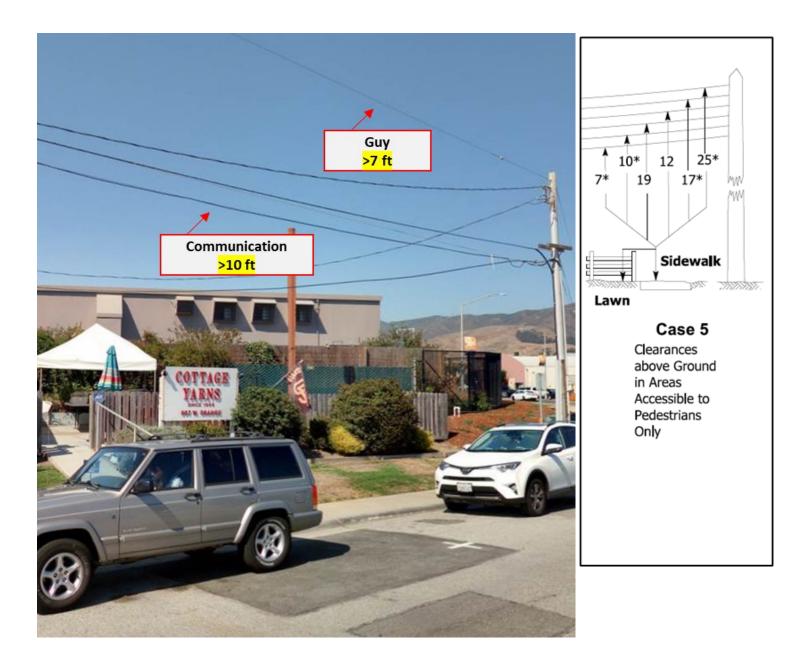
Case 5: Pedestrian Access - Sidewalk

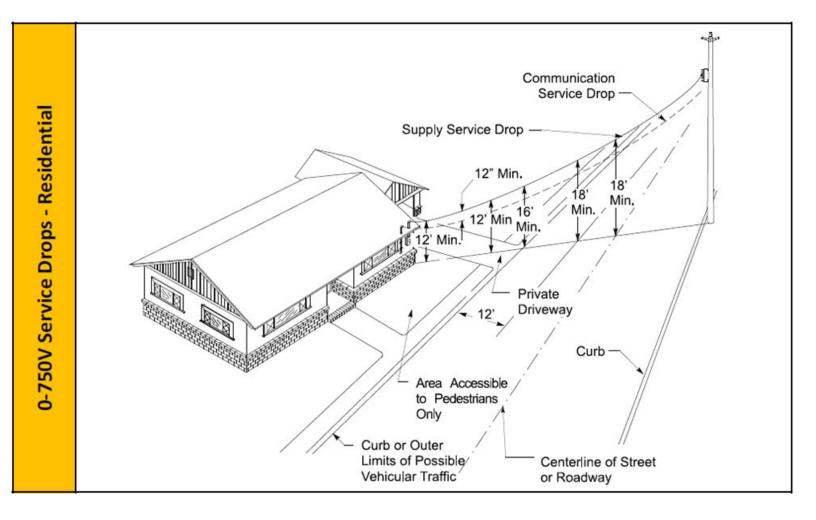
0-750V Service Drops – Residential

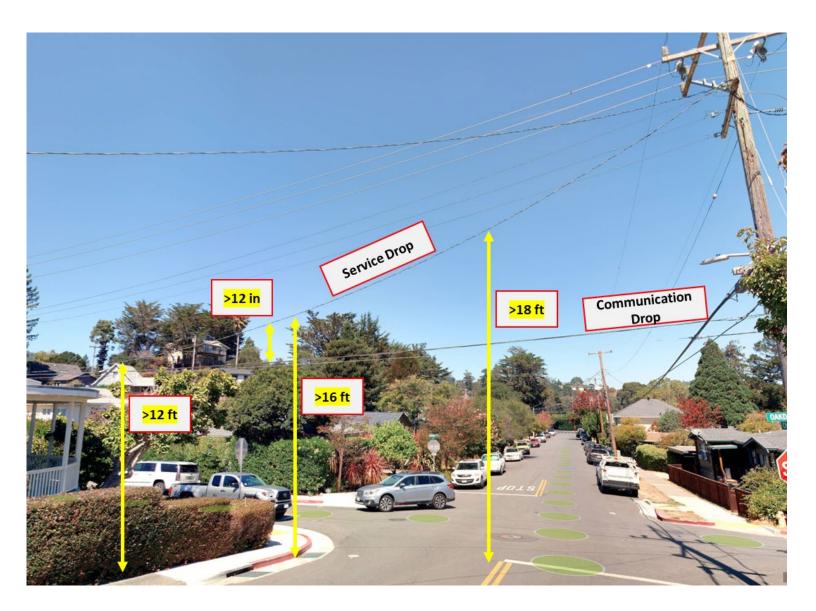
Service Drop – Residential

<u>NOTE</u>: Due to the fisheye lens and the online street view, the poles appear to be leaning but are not.

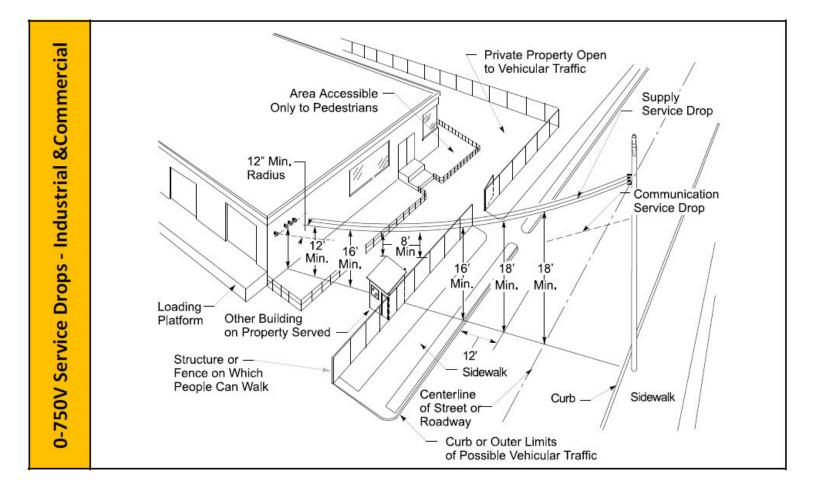
0-750V Service Drops – Industrial and Commercial

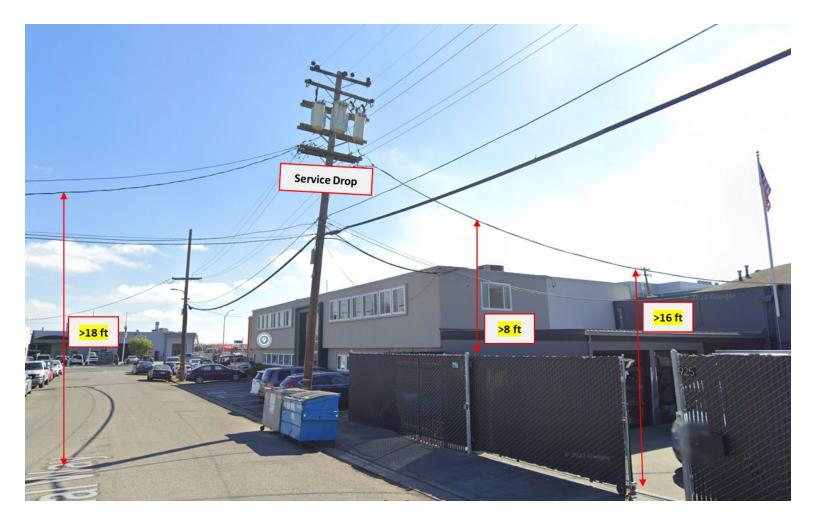
Service Drop – Commercial

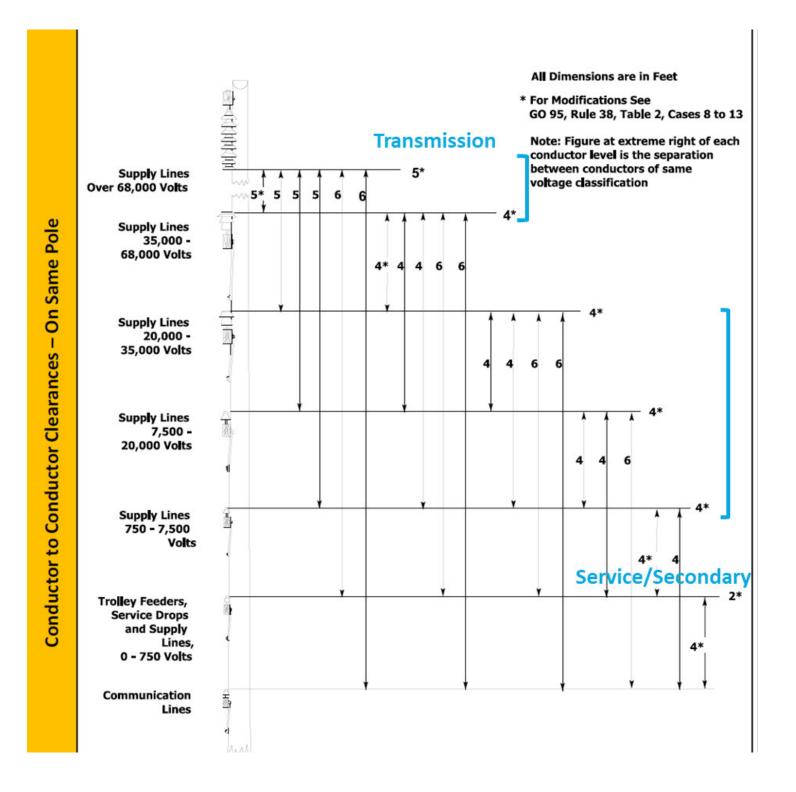
Conductor to Conductor Clearance – On Same Pole

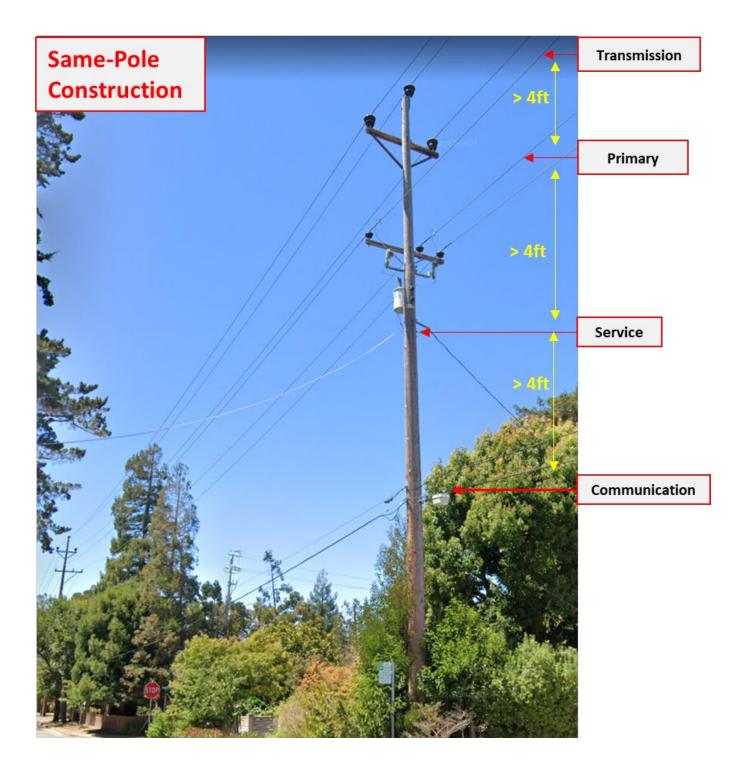
Same Pole Conductor Clearances

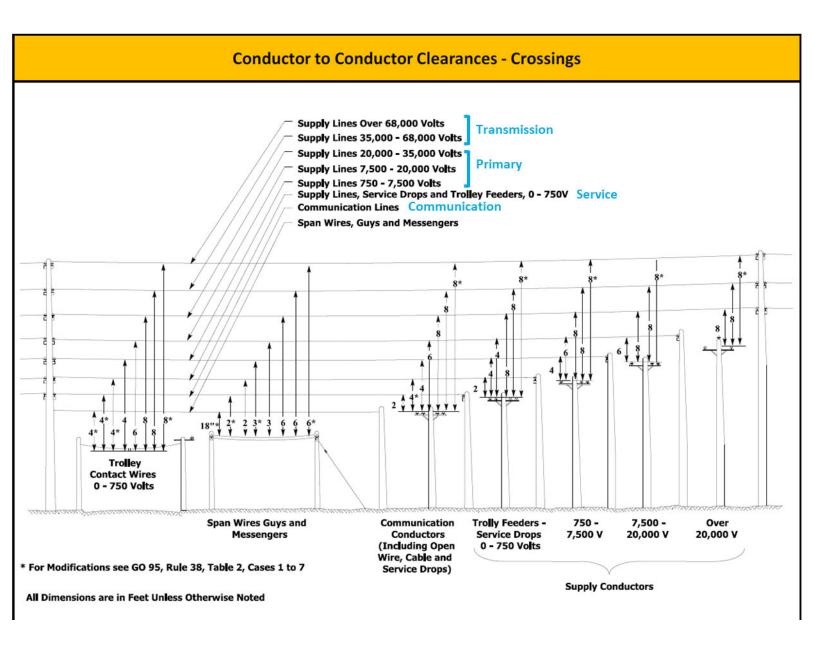
Conductor to Conductor Clearance on Crossing Poles

• 300kV plus transmission circuits require 156 inches of clearance to the primary.

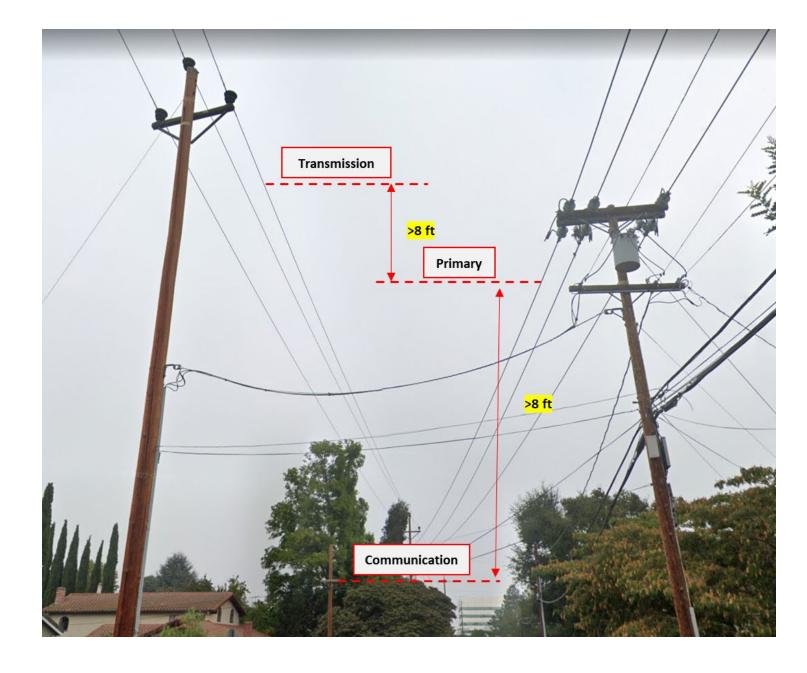
Crossing Poles Clearances

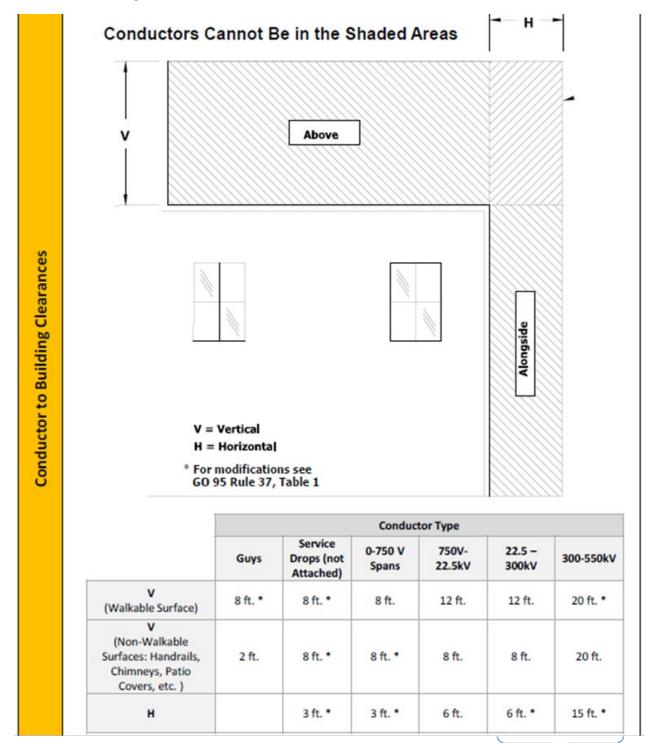
Conductor to Building Clearances

Service Secondary Primary Transmission

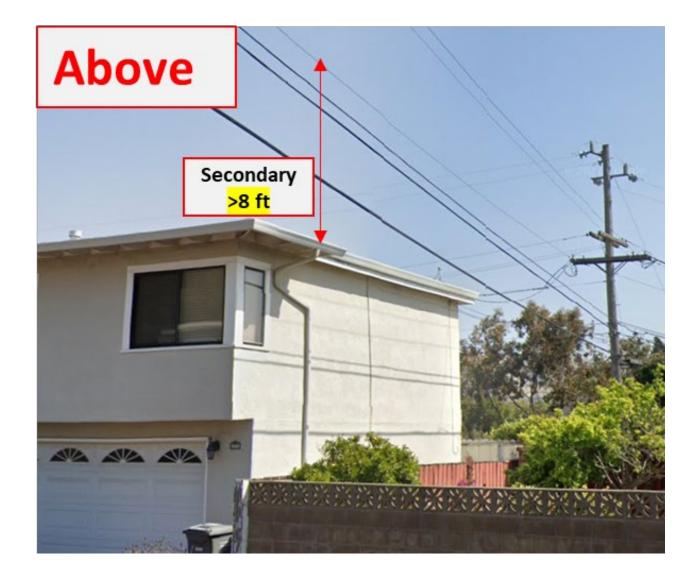
Above Building Clearance

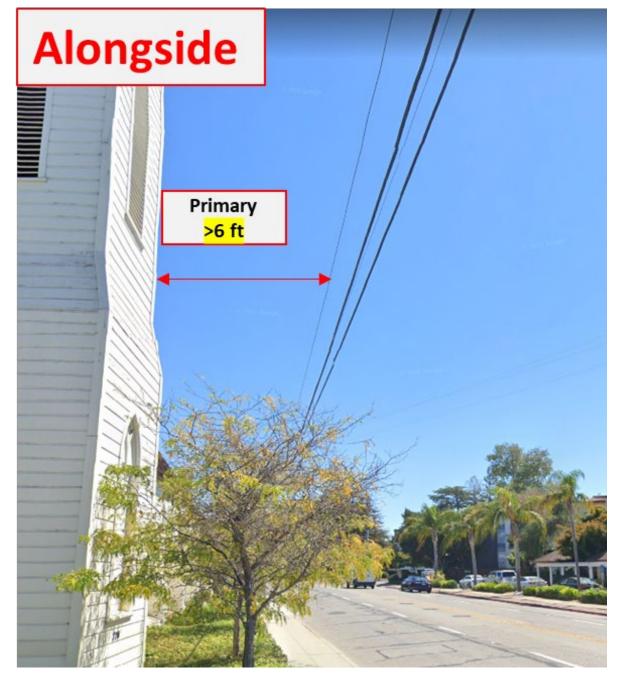
Alongside Building Clearance

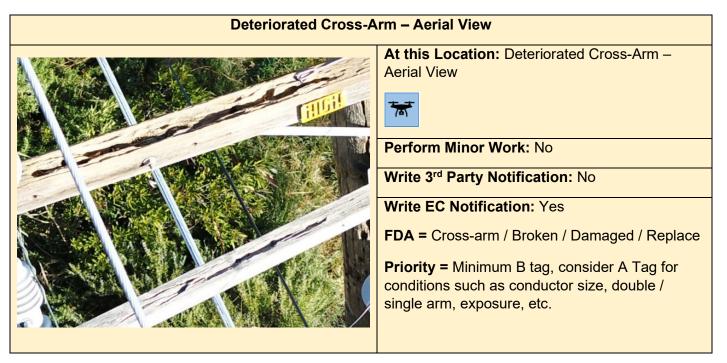
Deteriorated Cross-Arm – Aerial View	
	At this Location: Top view of a Deteriorated/Rotten cross-arm. May not be seen from the ground. Quarter brace hardware coming loose.Image: Image:

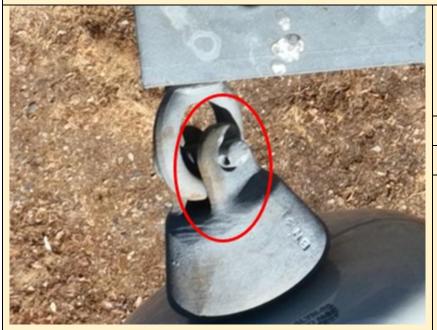
MISSING COTTER KEY / RETAINER PIN FULLY SEATED

At this Location: Missing Cotter Key / Retainer Pin Fully Seated, may fall out.

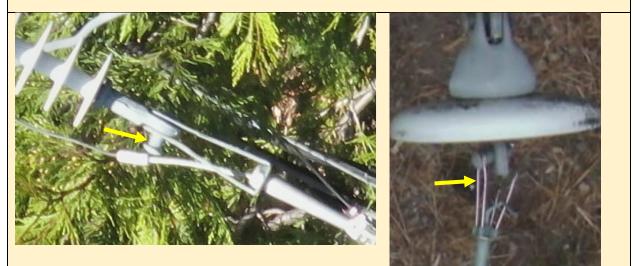
RETAINER PIN COMING LOOSE, ALMOST PULLED OUT

At this Location: Retainer Pin coming loose, almost pulled out.

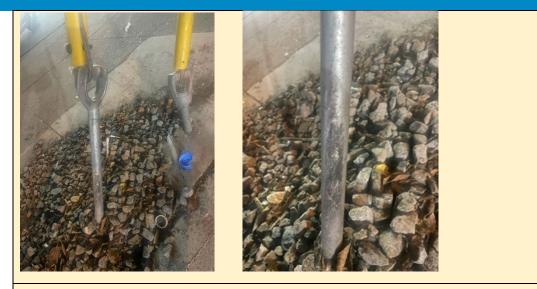
At this Location: Missing marker and visual strips. After marker is fixed, visual strips are still missing. Evidence of tire marks on anchor.

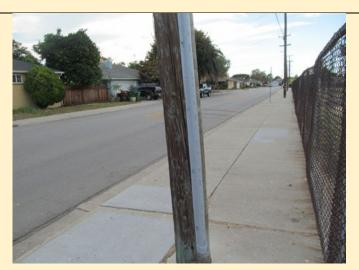
Before: Copper Wire sticking out from under the wood molding

After: 1.5-inch u-shaped molding installed over existing wood molding

At this Location: Wood molding with ground exposed

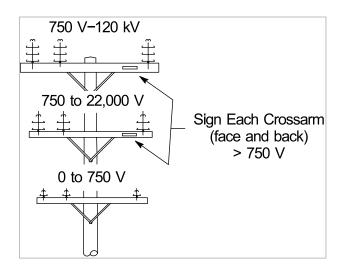
C. Sign Each Crossarm

Marking requirements are satisfied under this option <u>if each crossarm</u> (line arm) supporting line conductors in excess of 750V are signed both front and back. Signs are not required on the inside faces of double arms.

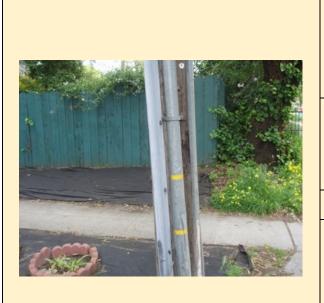
INADEQUATE VISIBILITY STRIPS

At this Location: Pole with vehicular exposure. Two small sections of yellow adhesive visibility strips.

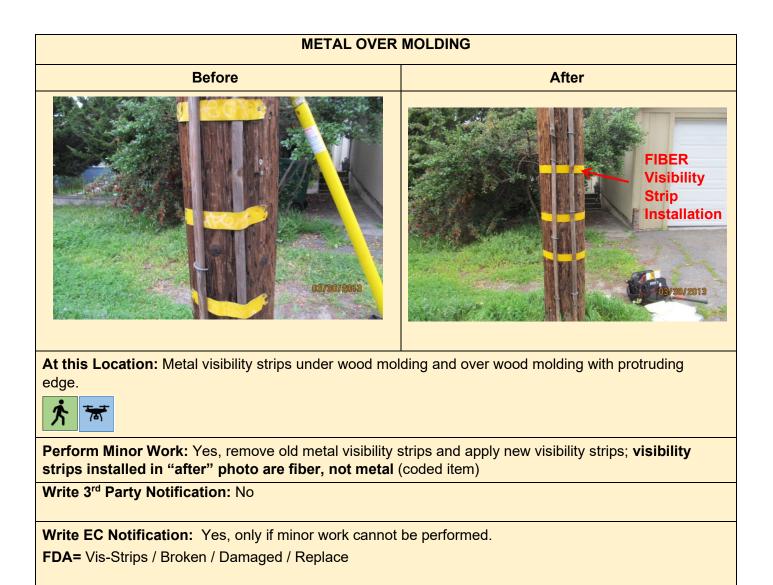
FDA= Vis-Strips / Broken / Damaged / Replace

Priority= At minimum – must write up as Priority F Tag next inspection cycle; based on field condition and exposure, corrosion, etc.; prioritize as needed (A, B, E, or F)

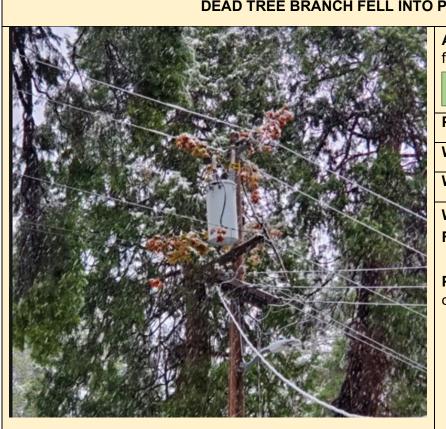
DEAD TREE BRANCH FELL INTO PRIMARY

At this Location: Dead tree branch fell into primary. No charring visible.

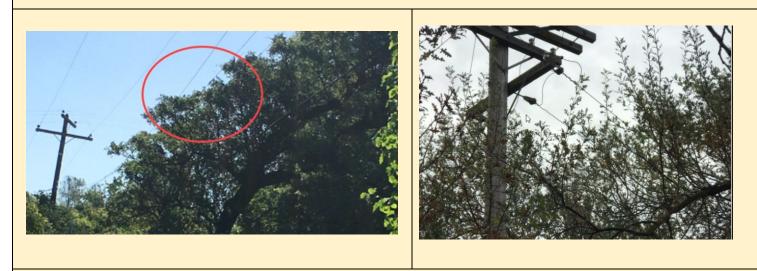
TREE GROWING INTO BARE OPEN WIRE SECONDARY OR BARE OPEN WIRE SERVICE, NO STRAIN OR ABRASION

At this Location: Tree grown around bare open wire secondary, no strain or abrasion. Spreader bracket already installed.

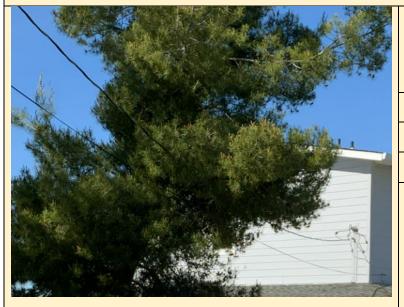
TREE GROWING AROUND SERVICE, NO STRAIN OR ABRASION

At this Location: Tree grown around service, no strain or abrasion.

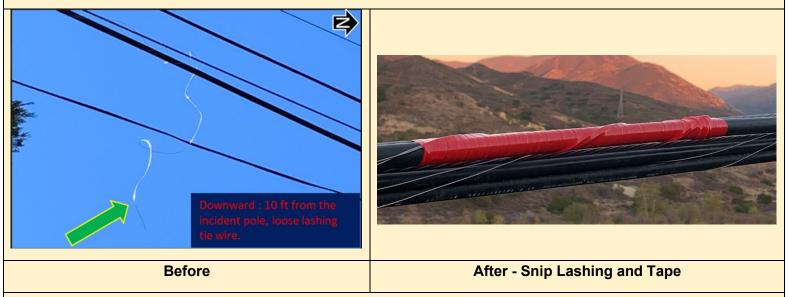
3rd PARTY CABLE LOOSE LASHING LONG ENOUGH TO WHIP INTO POWER LINES

At this Location: 3rd party communication line has a loose lashing long enough to whip into power lines. Standby situation.
