**Effectiveness and  
Implementation  
Considerations of Covered  
Conductors: Testing and  
Analysis**

Prepared for

Exponent  
149 Commonwealth Drive  
Menlo Park, CA 94025

December 22, 2022

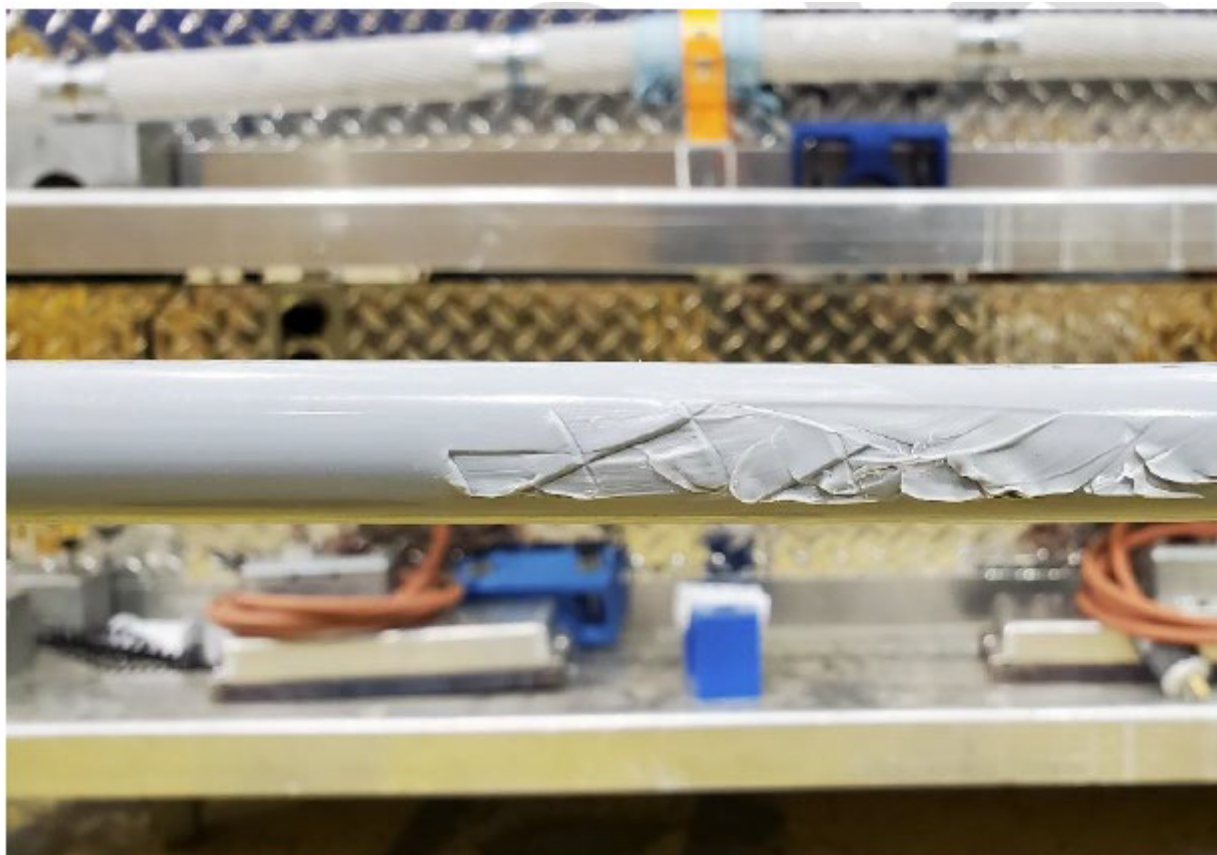
Figure 67. A representative post-test image of a 17-kV ACSR CC showing superficial damage to the polymer sheath caused by slippage.

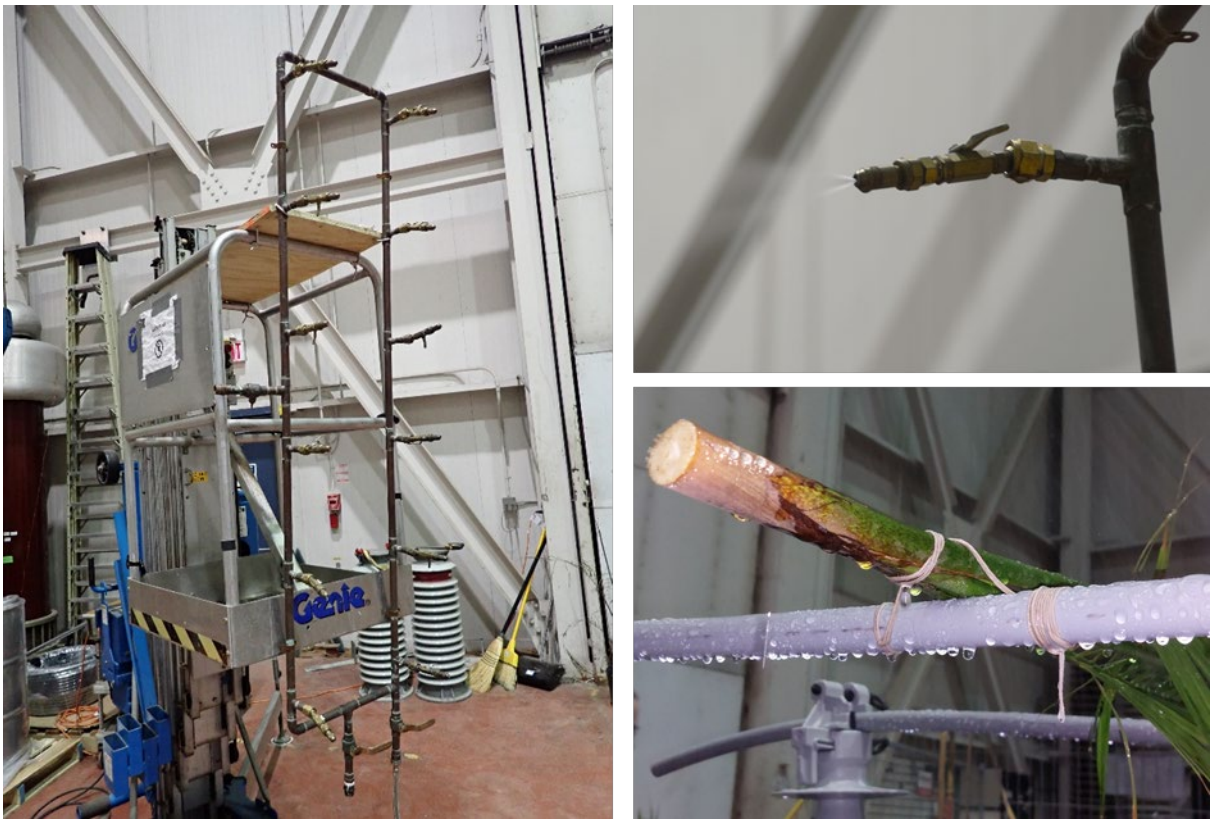
Figure A4. Wet test setup for phase-to-phase contact tests.

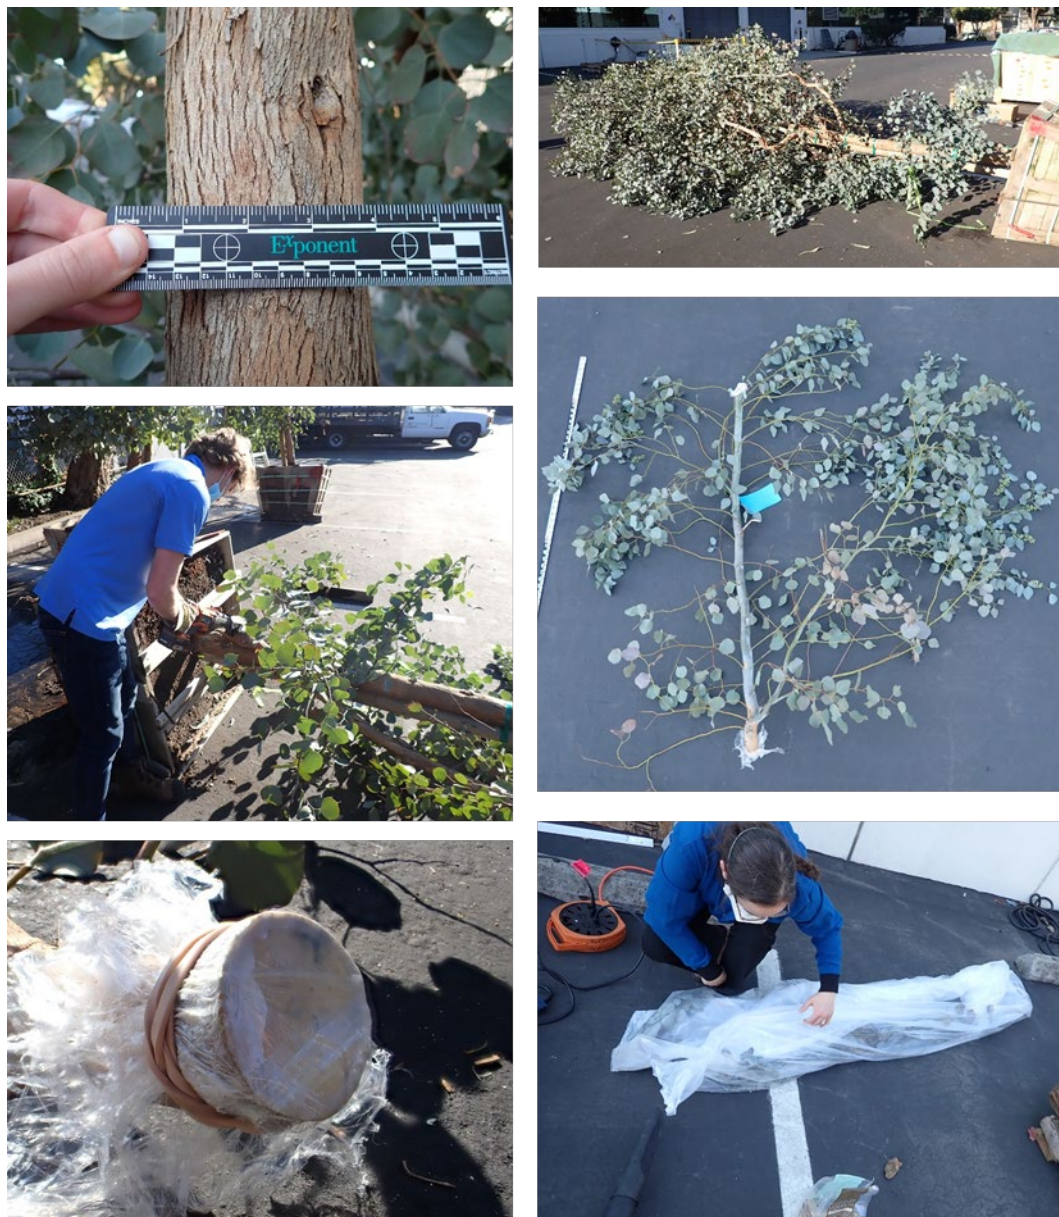
Figure A5. Cutting and preparation of leafy eucalyptus branches for phase-to-phase arc testing.

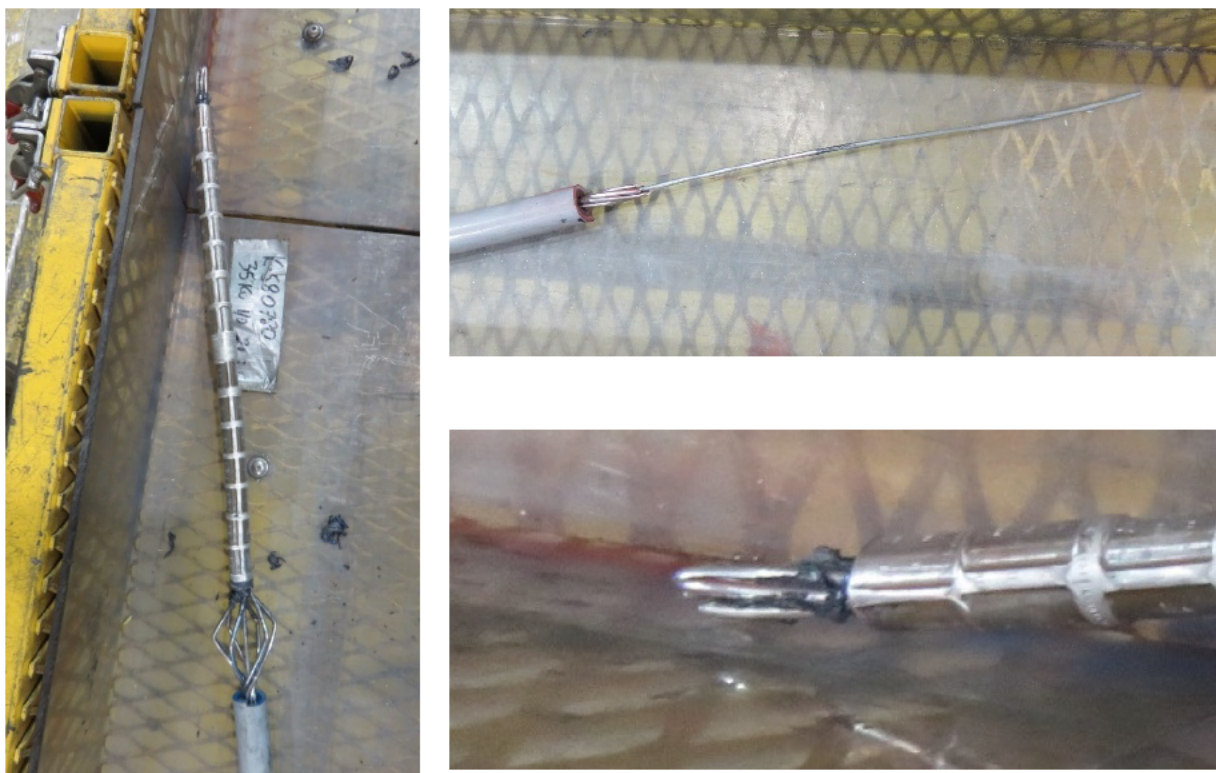
**Figure 6-8: Sample 1.2.1 after test (conductor failed at North end of splice)**
