Preliminary Ignition Investigation Report

Ignition Database Index:	20240753
Electric Incident Investigation (EII) Number:	N/A
Incident Name:	Morro - 25 Jun 2024
PG&E Facility Ignition?	Yes
CPUC Reportable Ignition?	Yes
Date & Time of Incident:	June 25, 2024 @ 2013 hours
Street Address:	In the vicinity of 10450 Morro Road, Lewis Highway 41 and Toloso Road.
City:	Atascadero
County:	San Luis Obispo
Latitude/Longitude:	35.456902, -120.687541
State Responsibility Area (SRA) / Local Responsibility Area (LRA) / Federal Responsibility Area (FRA)	Local Responsibility Area (LRA)
PG&E Division:	Los Padres
High Fire Threat District (HFTD):	Tier 2
High Fire Risk Area (HFRA):	Yes
EPSS Buffer:	No
Fire Index Area (FIA):	575
Fire Potential Index (FPI) Rating: FIA	R3
Fire Potential Index (FPI) Rating: Circuit	R4
Was there a PSPS event at the time of ignition?	No
Suspected Initiating Event:	Utility work / Operation
Failure Driver:	Utility work / Operation
Failure Sub-driver:	Equipment failure - Other

Circuit:	Atascadero 1103
Circuit Protection Zone:	Atascadero 1103440856
Nominal Voltage:	12kV
Pole SAP Equipment ID:	SAP Pole ID: 101932126
Subject to PRC 4292 Veg Pole Clearance:	No
PG&E Equipment ass

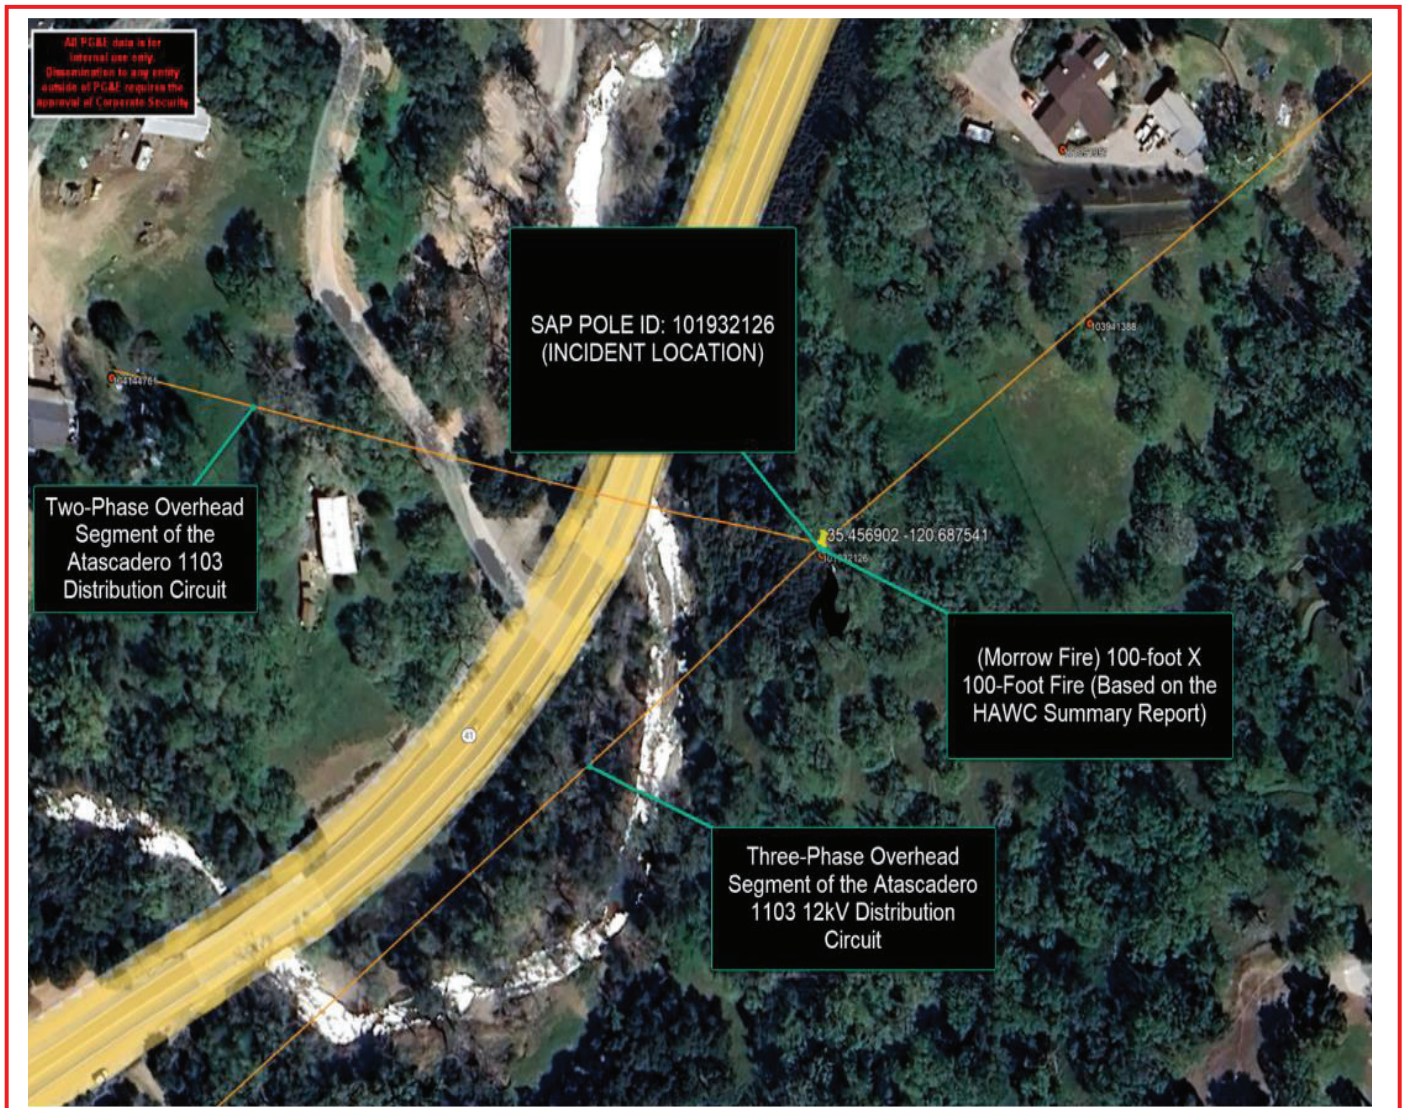
Figure 1 - Google Earth Diagram of the Atascadero 1103 12kV Circuit. The location of the fire is approximate based on reports and pictures provided.

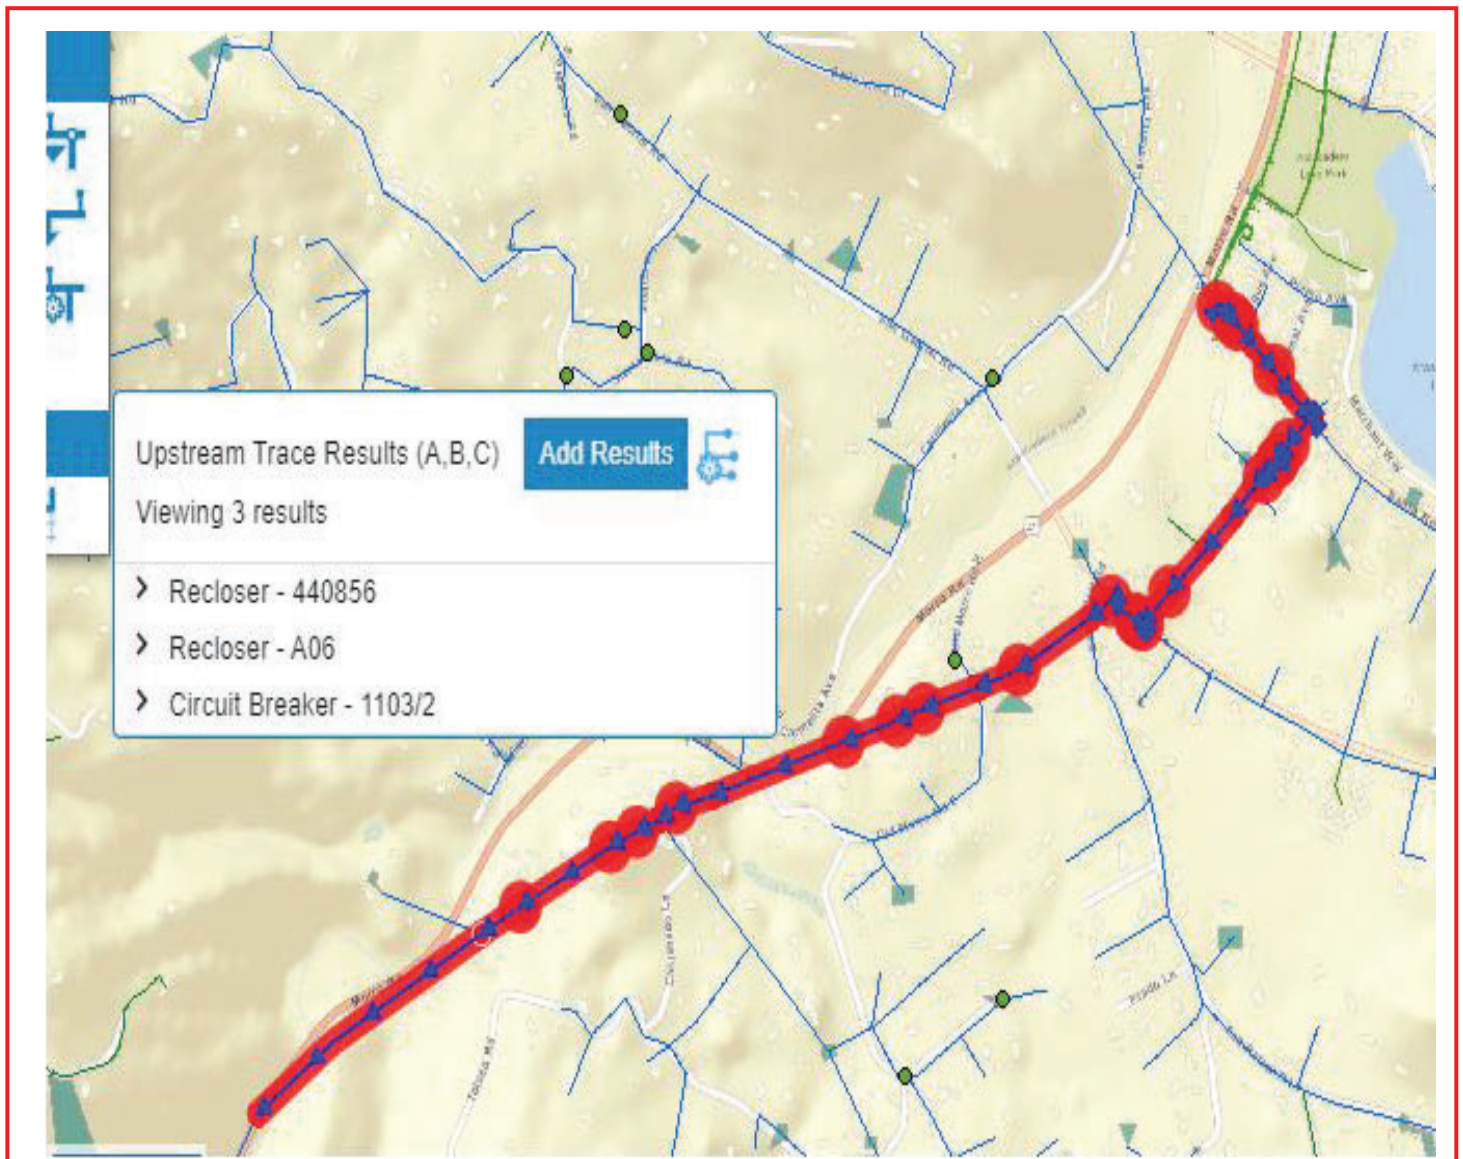
Figure 2 - EDGIS Diagram of the Atascadero 1103 12kV distribution circuit and upstream dynamic protective devices between the Substation and Incident location.
